Analysis of Simultaneous Operational Failure of Critical Facilities due to Earthquake, for a California Utility

Prepared by
CALIFORNIA INSTITUTE OF TECHNOLOGY

**Aug 7, 2006
Rev 1**

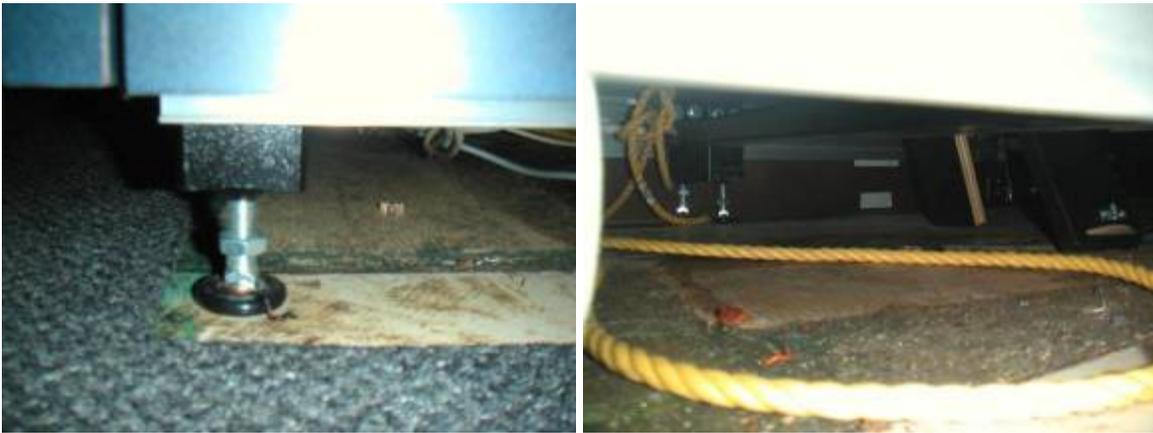
Figure 3-4. Grid control room consoles appeared to lack seismic restraint

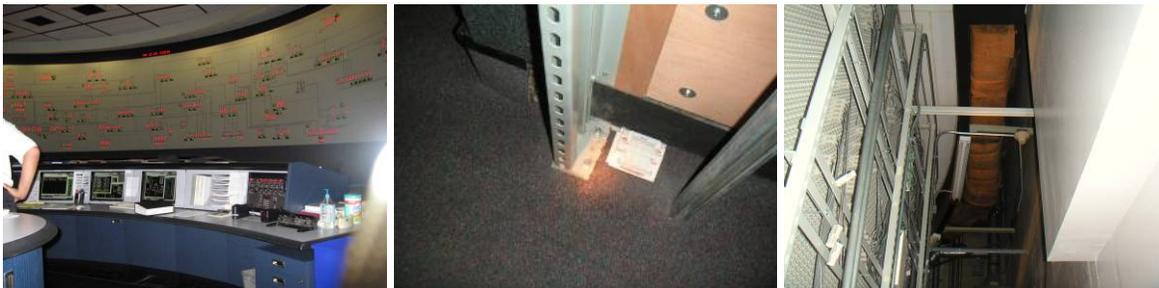
Some of the computer monitors and system units (the boxes that house the disk drives, system board, central processing unit, etc.) in the consoles were observed to be restrained against sliding, and some appeared to be unrestrained (Figure 3-5). Lack of restraint tends to increase the probability that the component will slide, overturn, and possibly cease to operate in the event of an earthquake. Unrestrained computers and monitors could be a weak link at this facility. The large display board contains a number of liquid crystal displays, which appeared to be well secured to a Unistrut steel frame, itself apparently anchored to the floor and wall (Figure 3-6).

Figure 3-6. Grid display board (left), and its restraint at bottom (center photo) and top (right)

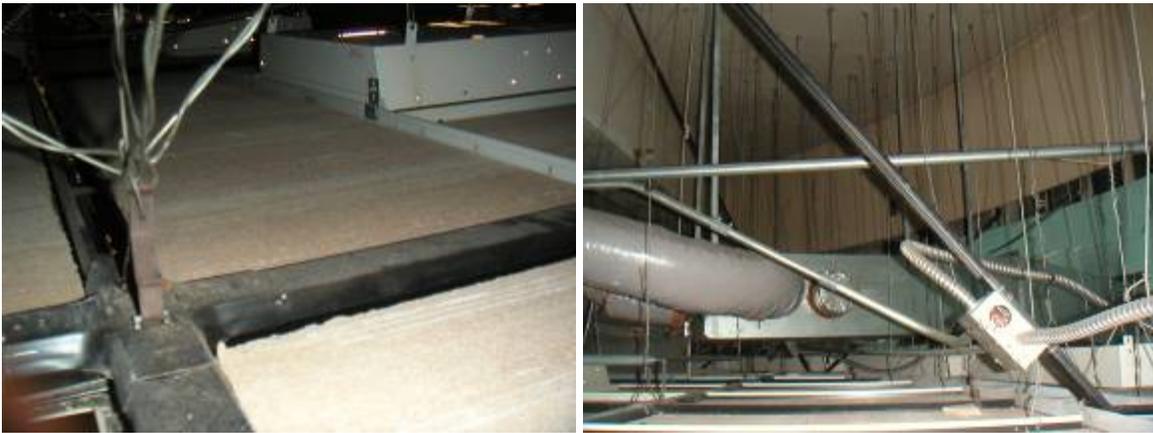
The overhead suspended ceiling system appeared to lack compression struts, although splay-brace wires were present (Figure 3-7). (Compression struts are rigid rods extending vertically from the ceiling framing members to the floor slab above, and are required by building codes for seismic resistance; the wires alone are considered inadequate to prevent ceiling collapse.) In practice, if the ceiling extends to the walls of the room, the walls tend to restrain (or “capture”) the ceiling more effectively than compression struts and splay braces, but the ceiling in this room does not extend to all the adjacent walls, and instead slopes up to the ceiling on the side of the room where one enters (i.e., opposite the display boards). Light fixtures near the point of observation had safety wires, used to inhibit the fixtures from falling if the ceiling collapses (Figure 3-8).

Figure 3-7. Suspended ceilings in grid control room.

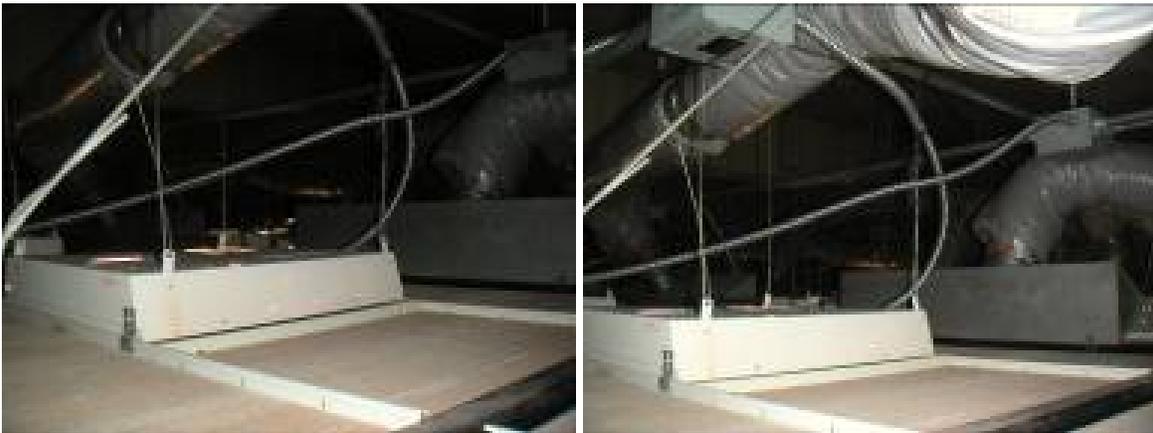
Figure 3-8. Safety wires observed on light fixtures in grid control room ceiling

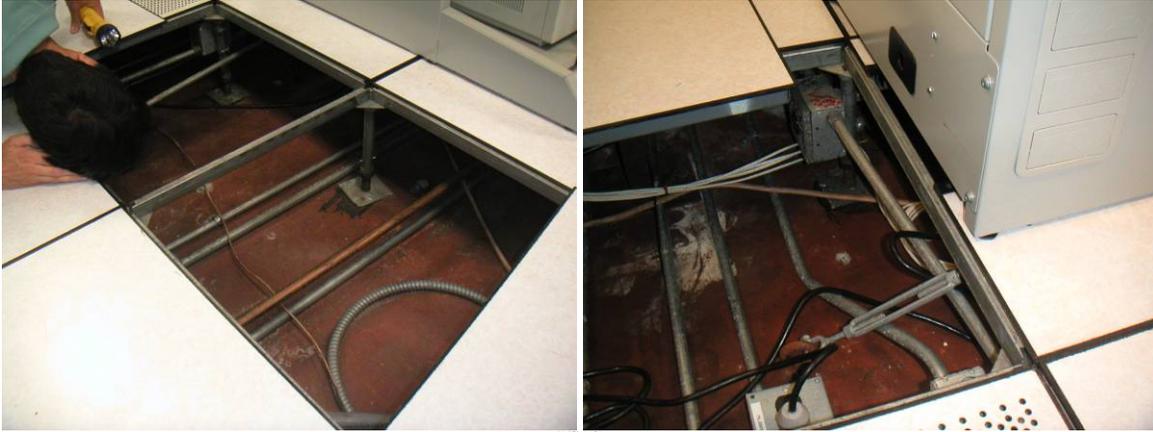
Figure 3-9. Anchorage of pedestals in main computer room raised access floor

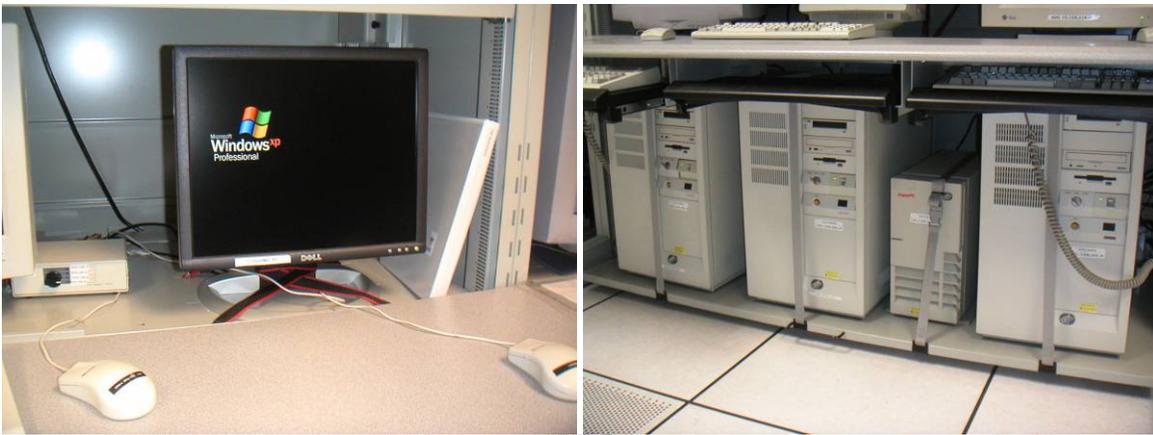
Figure 3-10. Restraint of computer equipment in main computer room

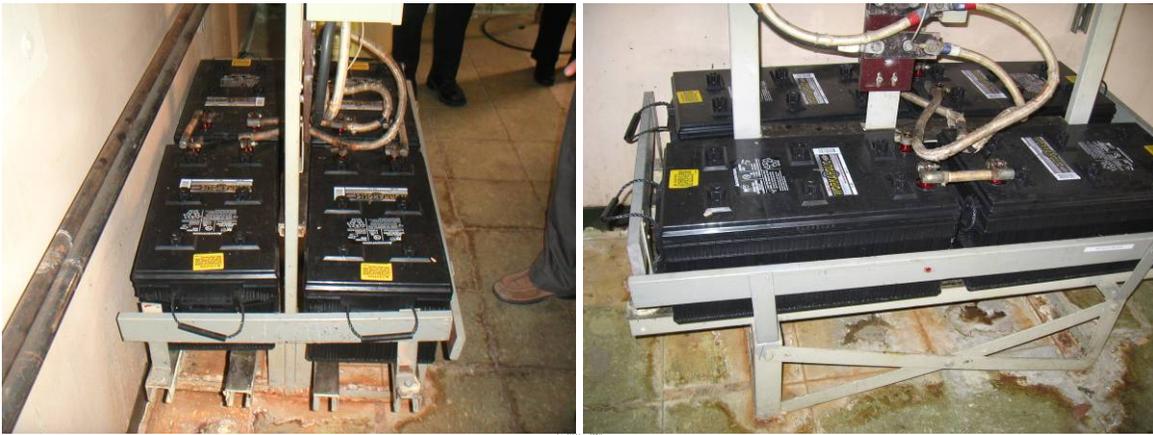
Figure 3-16. Battery rack for GCF generator starter motor was anchored but batteries lacked spacers

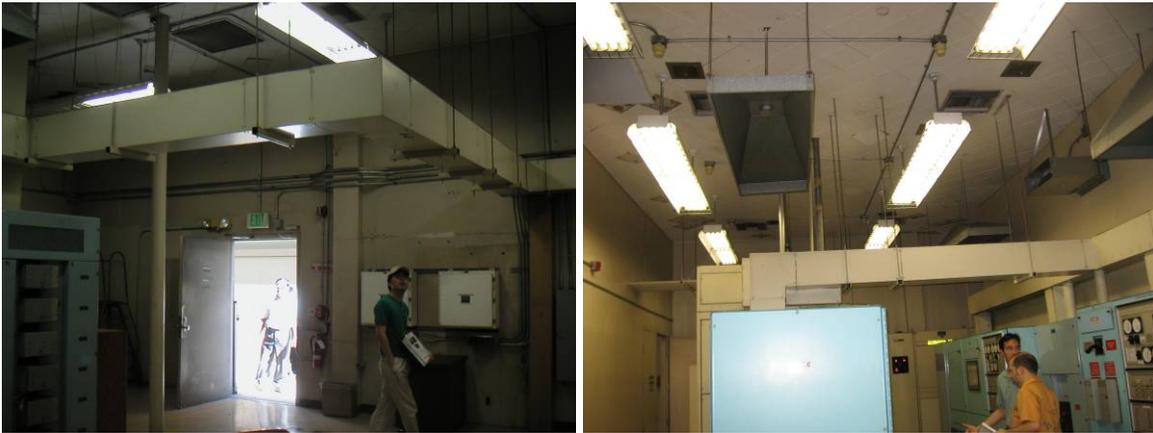
Figure 3-19. Cable trays and lights in GCF electrical equipment room

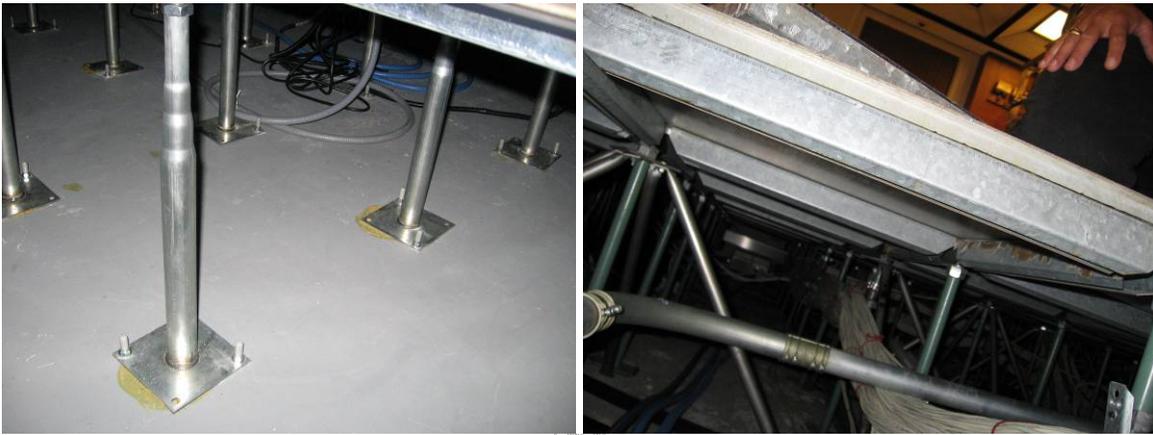
Figure 3-25. Raised access floor appears to be unbraced in ITOC room (left), although bracing is present in the ITOC equipment room (right).

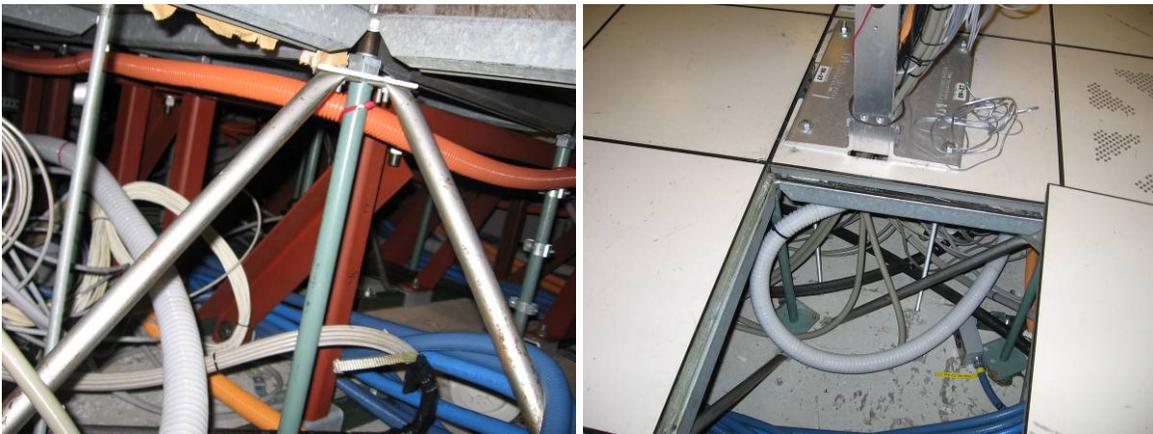
Figure 3-26. Red members behind the floor pedestal are steel framing to support heavy equipment in ITOC equipment room (left); lighter equipment secured with vertical rods (right).

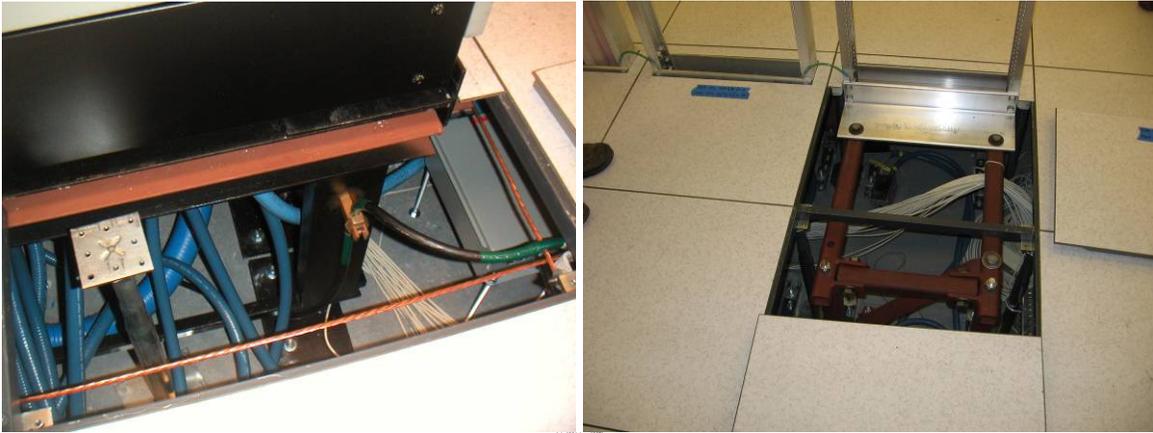
Figure 3-28. Steel frames used for some equipment in CPU rooms 1 and 2

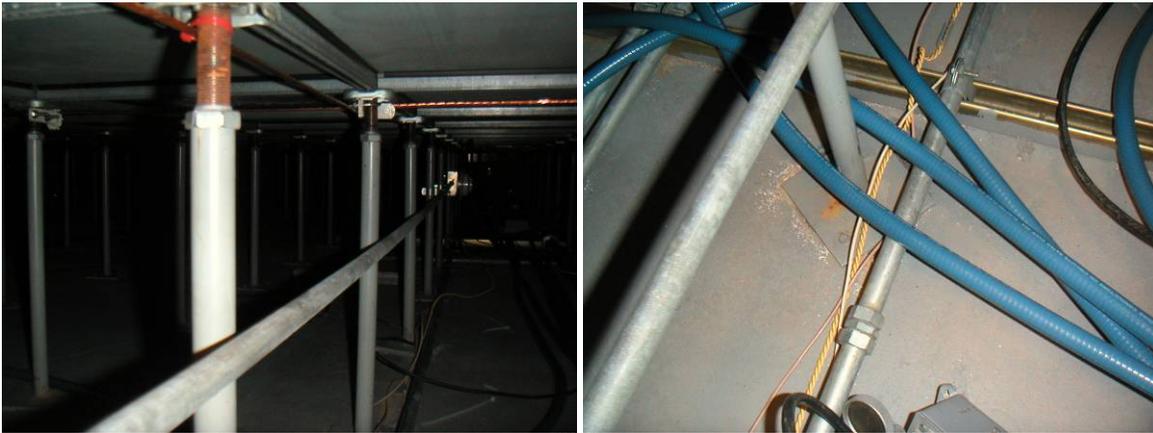
Figure 3-33. Raised access flooring in DPF tape silo room

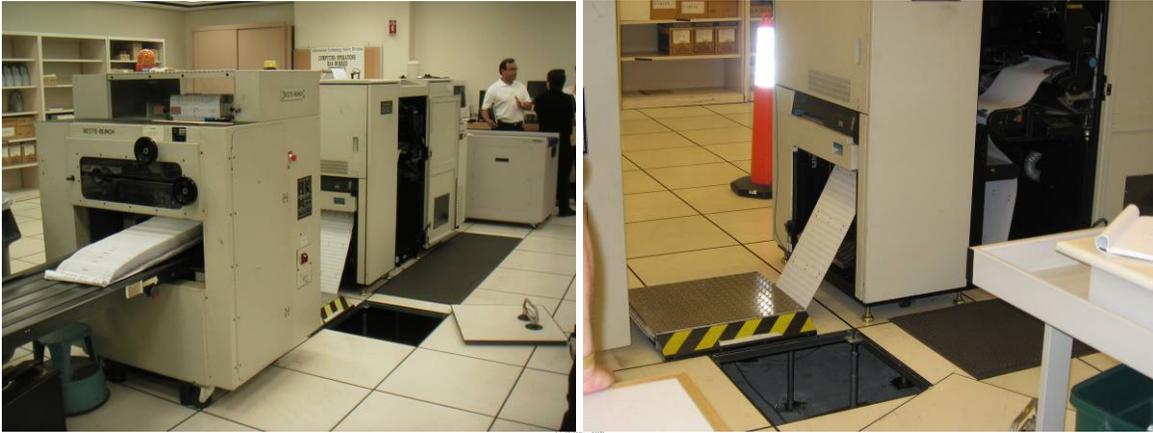
Figure 3-35. DPF printer room equipment

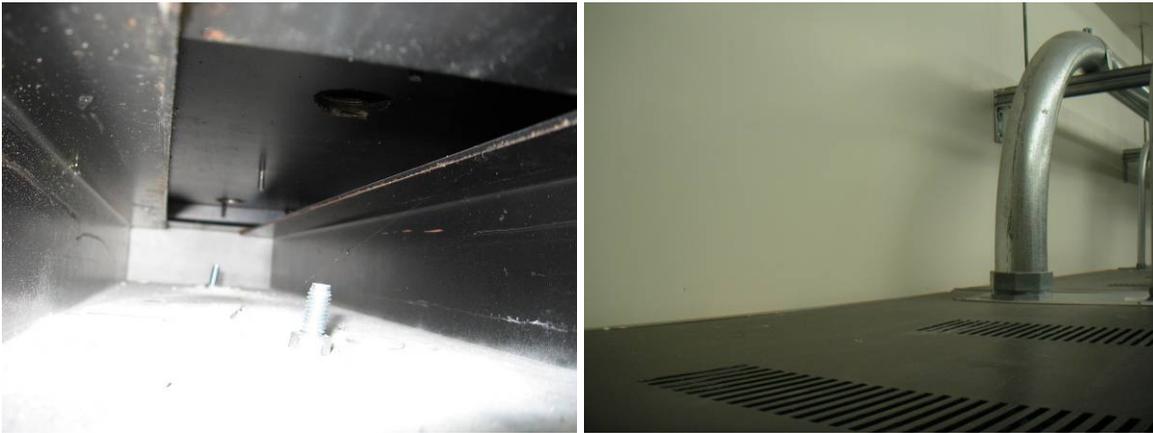
Figure 3-38. Apparent anchorage at base (left) but not at top (right) of DPF battery-rack cabinets

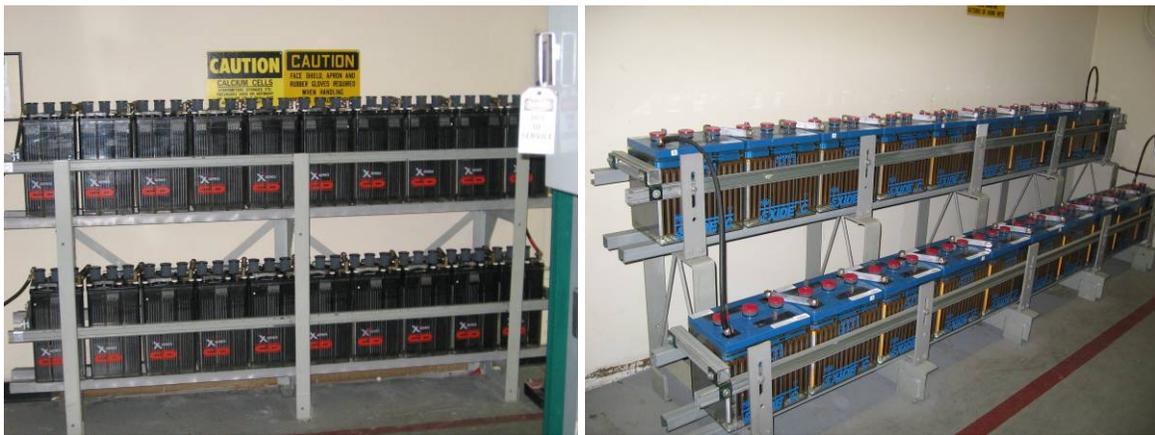
Breaker battery racks. We observed battery racks that building engineers suspected serve circuit breakers, as opposed to the main UPS (Figure 3-41). These racks have battery restraints and longitudinal braces but lack spacers between the batteries. Spacers (often Styrofoam sheets placed between batteries) are an attempt to prevent the batteries from shifting within their frame and breaking the conductors between adjacent batteries. The lack of spacers increases the probability that an earthquake would damage the conductors and prevent the battery rack from supplying power; this shortcoming may be a weak link at this facility.

Figure 3-41. Battery racks serving breakers

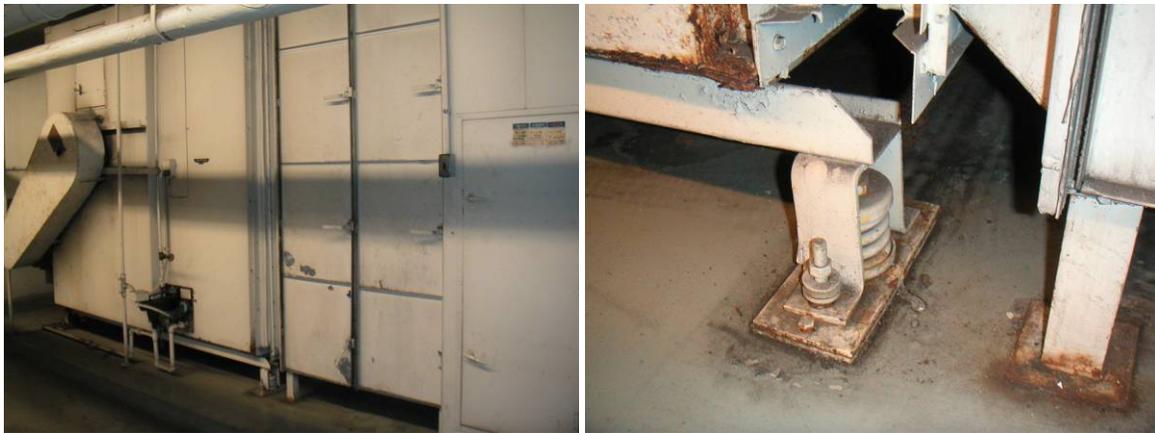
are on vibration isolators without seismic snubbers (Figure 3-42). (Seismic snubbers are metal fixtures attached to the slab next to a vibration-isolated mechanical device to restrain the device's lateral movement; an example is shown in Figure 3-43). The AHUs are rigidly attached to piping that could be damaged by excessive displacement of the AHU in an earthquake (Figure 3-44), which is another issue that tends to raise the probability of operational failure. Note that two of the four AHUs are needed. Lack of seismic restraint for these AHUs is a potential weak link at this facility.

Figure 3-42. Air handling units in DPF on isolators apparently without seismic snubbers

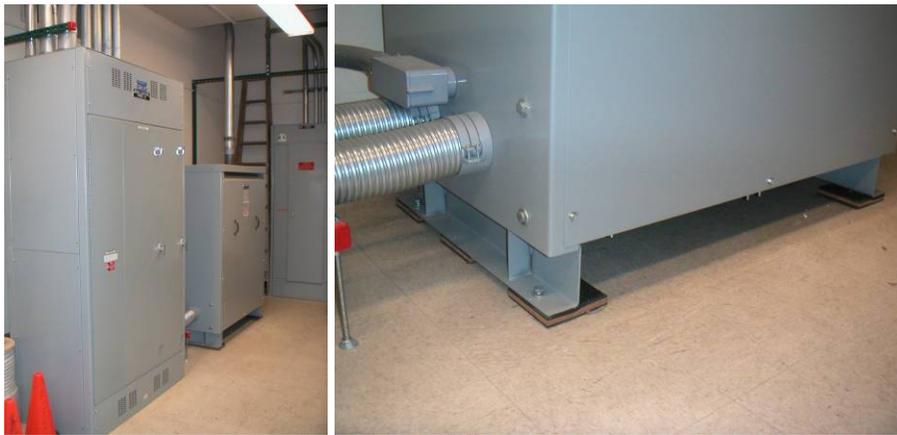
Figure 3-48. Anchorage of electrical equipment near DPF generator

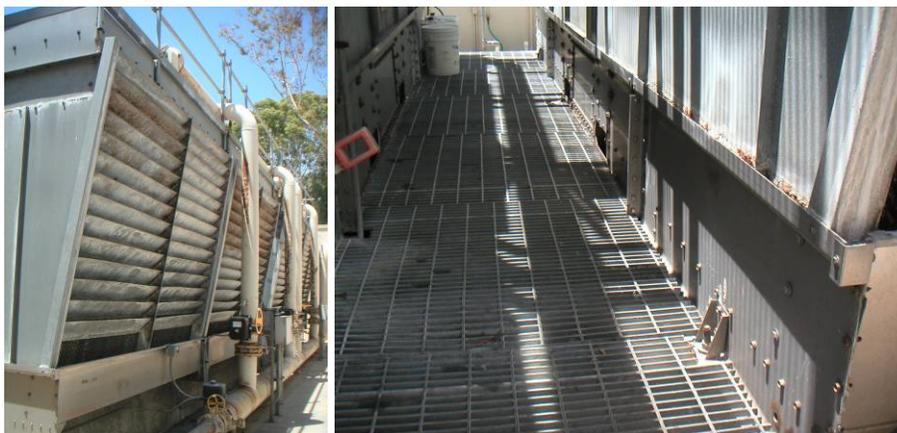
Cooling towers at DPF appeared to be seismically anchored. DPF does not have an on-site water supply, and it is of concern that if the local water supply is interrupted in an earthquake, evaporation of the water in the cooling towers could render the air conditioning at this facility inoperative; this may be a weak link at this facility, which could be remediated by providing a backup water supply for the cooling towers.

Figure 3-49. Cooling towers at DPF and their anchorage. This facility lacks an on-site backup water supply in case the local water utility is damaged.

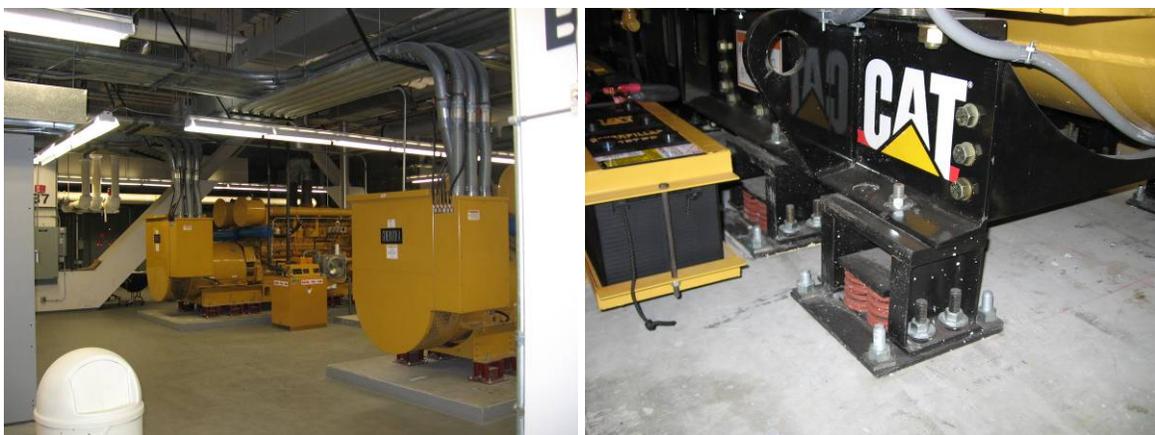
Figure 3-50. Generators and their seismic isolators at BDF

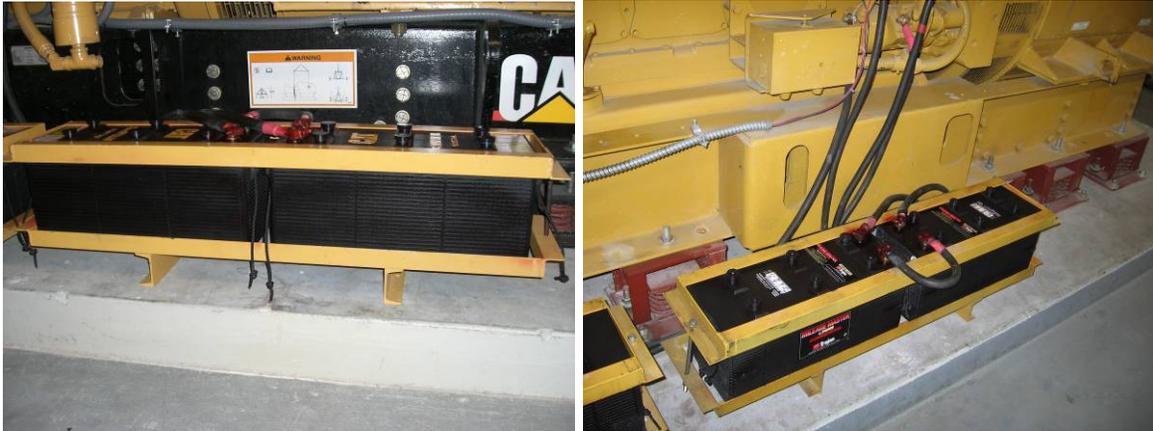
Figure 3-52. Apparently unanchored starter-motor batteries for generators at BDF

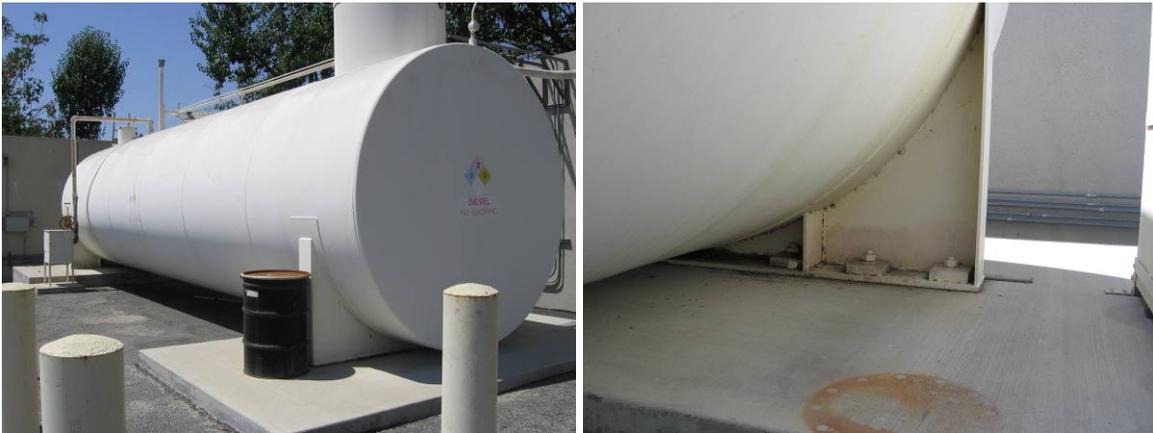
Figure 3-53. Diesel fuel tank at BDF apparently anchored to its plinth

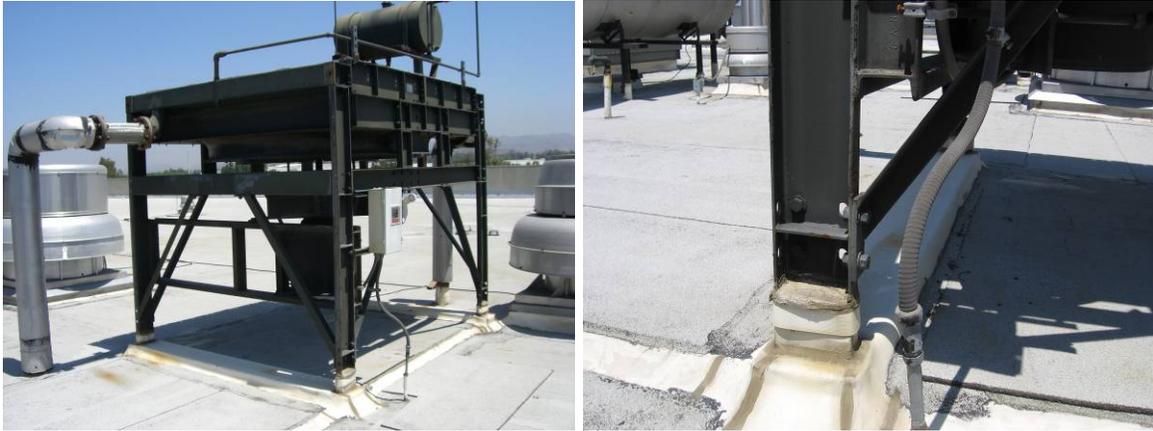
Figure 3-56. Radiator for BDF emergency generator

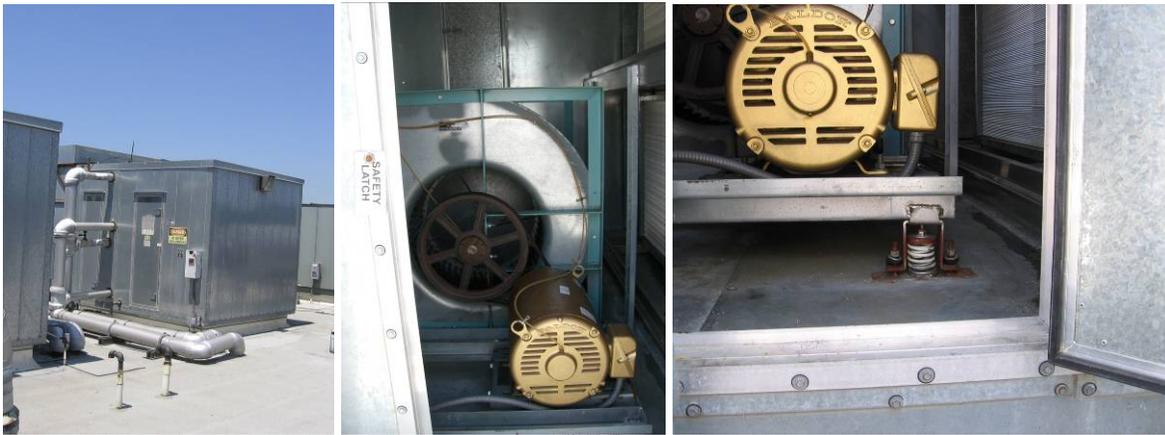
Figure 3-58. Enclosure with generator air supply fan and pre-cooling equipment. Isolator appears to have questionable seismic restraint

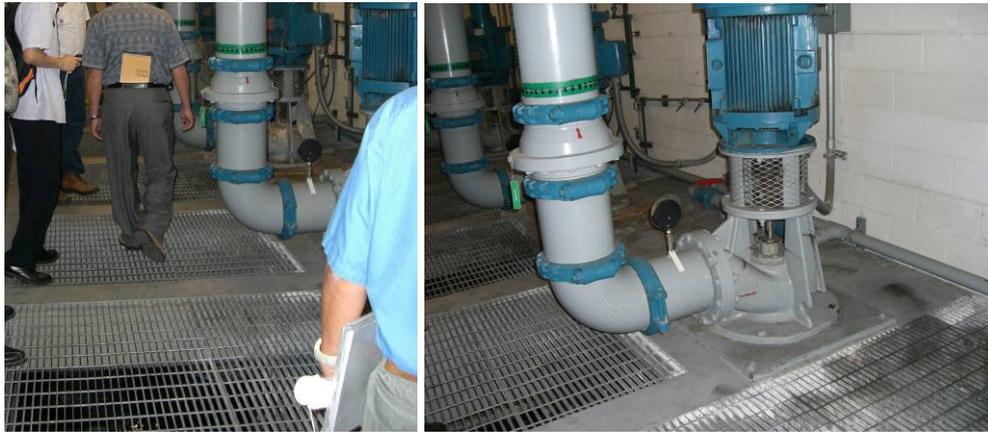
Figure 3-60. On-site water supply at BDF for use by cooling towers

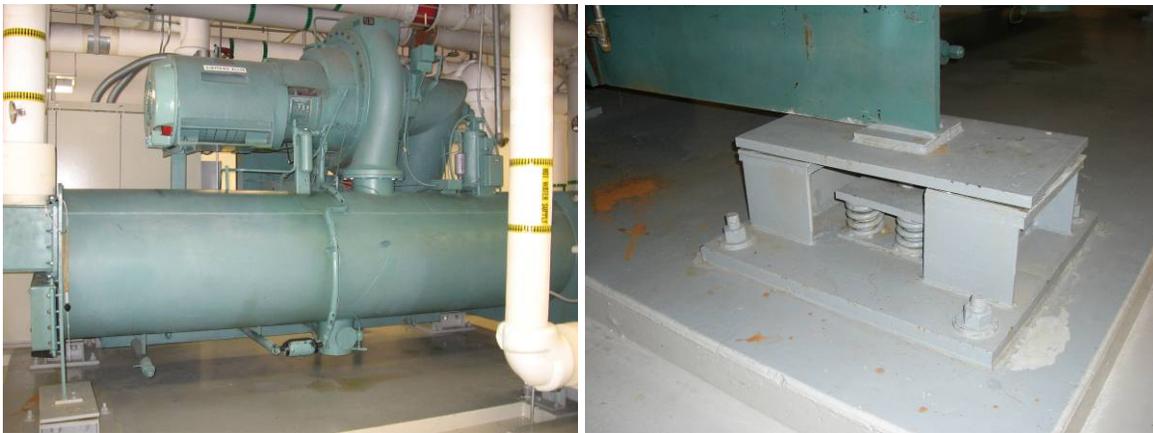
Figure 3-61. Chillers and their seismic anchorage in BDF

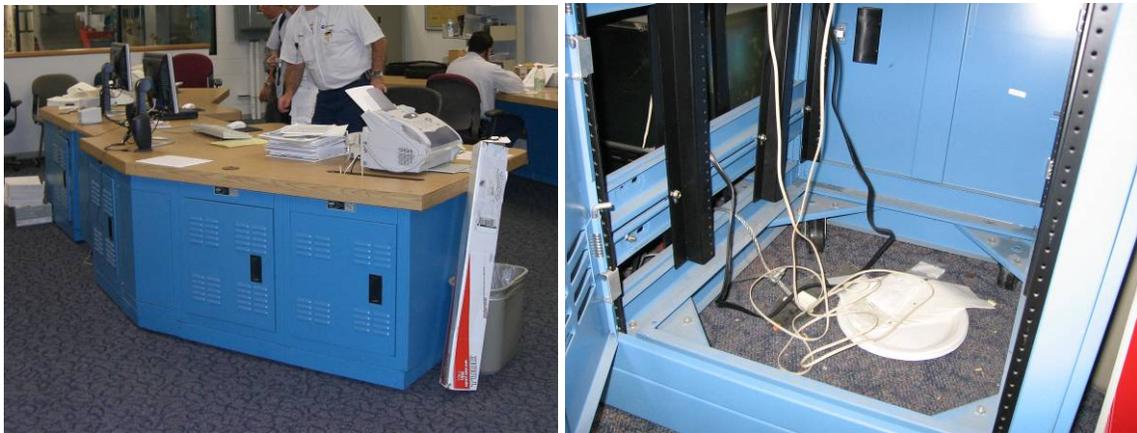
Figure 3-65. Desks in BDF building control room appeared to be tethered to the slab

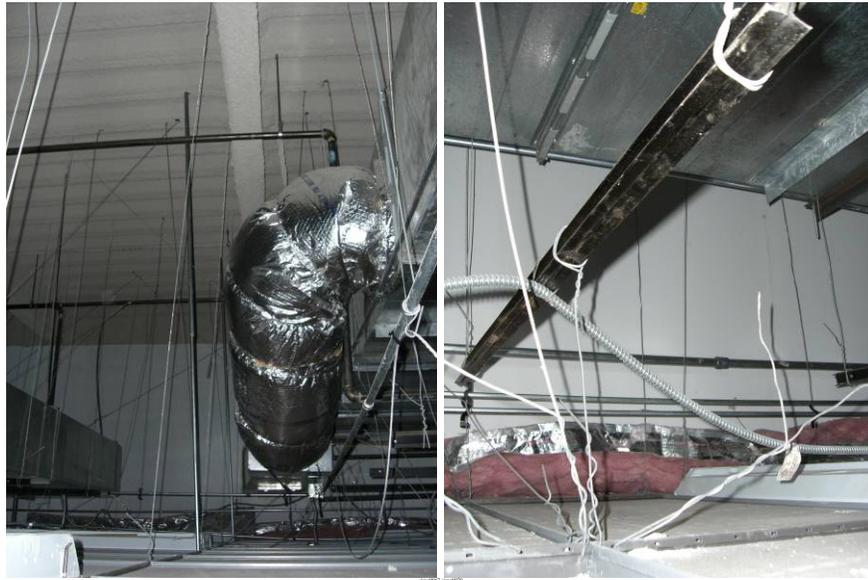
Figure 3-67. Compression struts and diagonal splay wires in BDF building control room ceiling

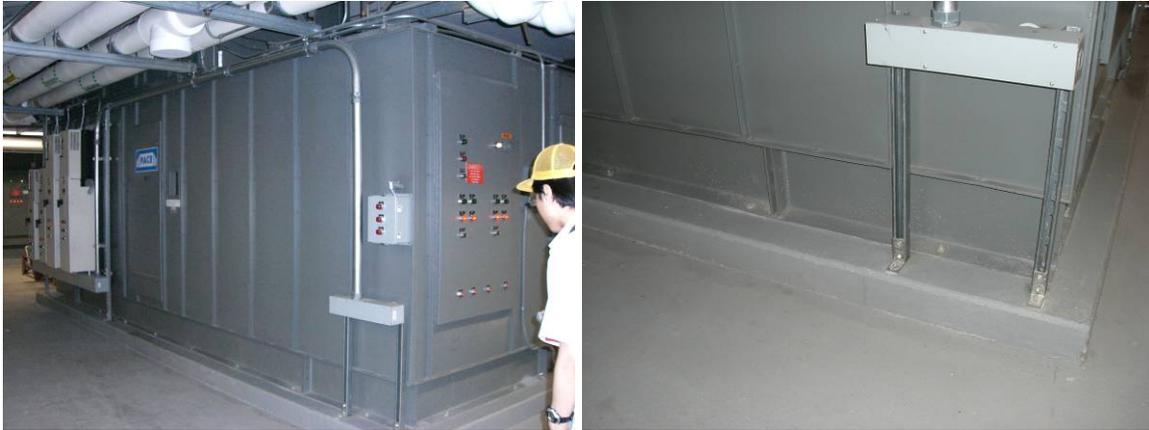
Figure 3-70. Air handling units in BDF appeared to be anchored to their plinths

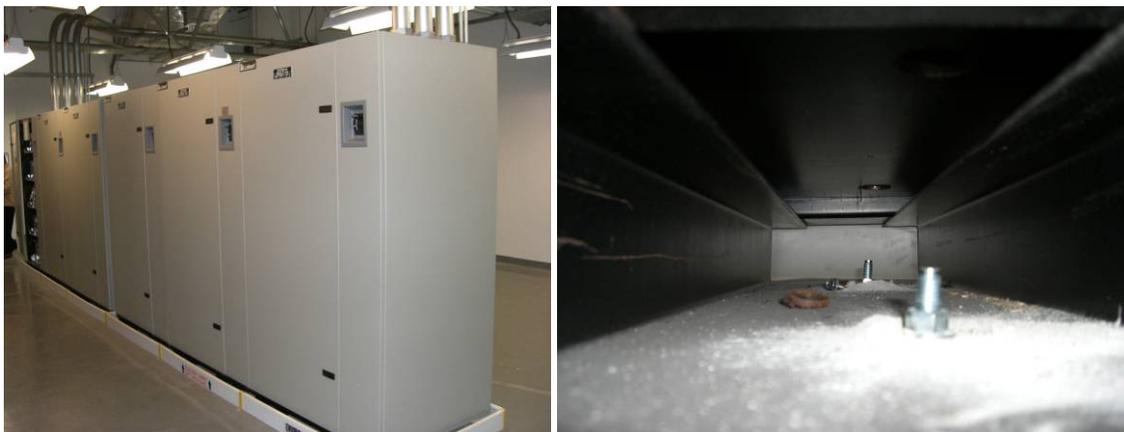
Figure 3-71. UPS equipment apparently anchored to slab

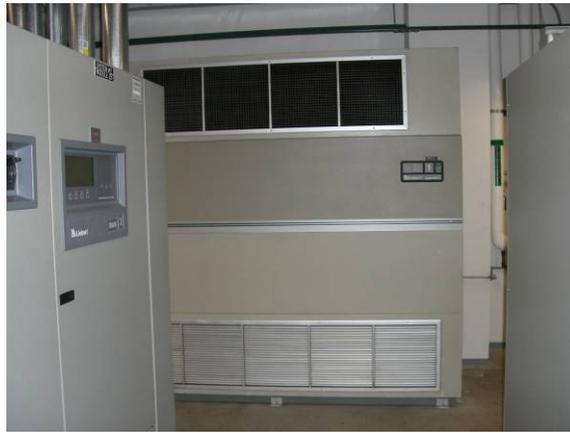
Figure 3-75. Air conditioning equipment near BDF UPS cabinets, apparently anchored to the slab

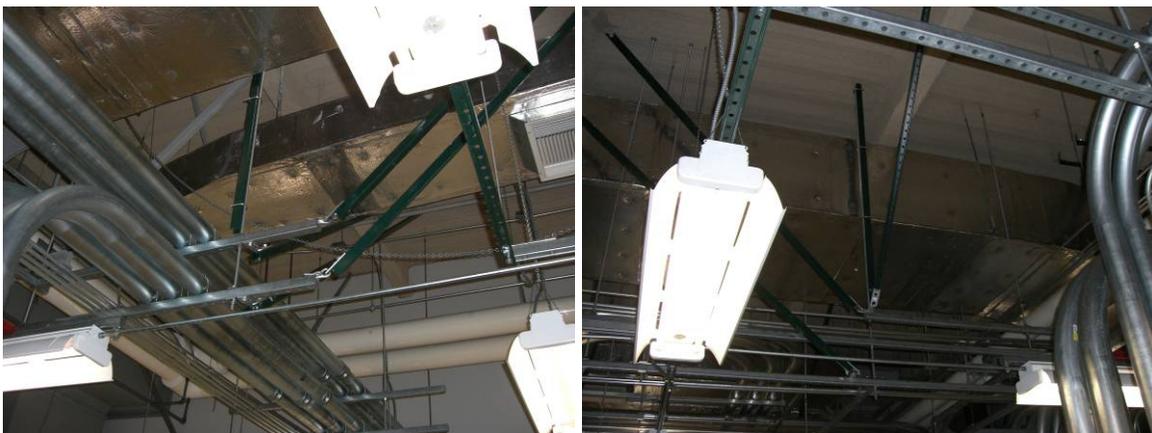
Figure 3-76. Overhead electrical ducts and hanger braces at BDF

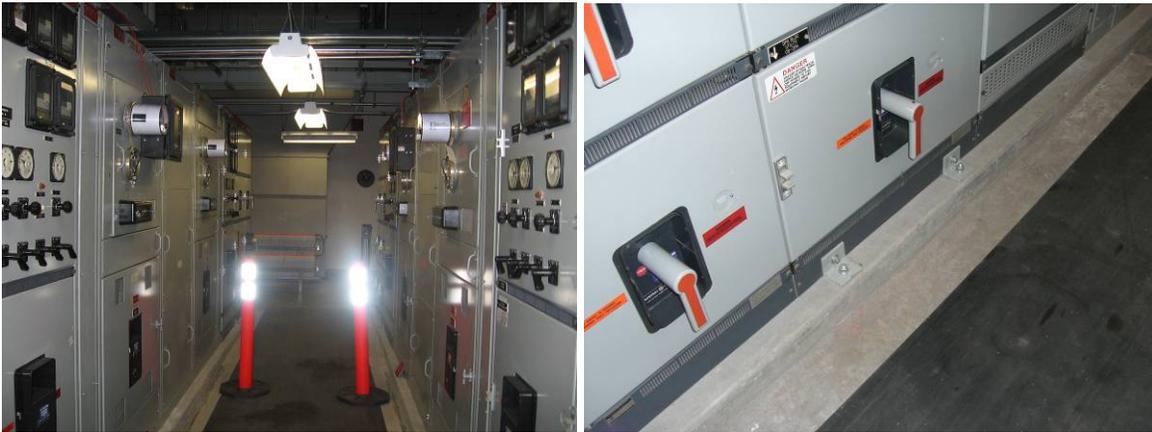
Figure 3-78. BDF switchgear and its anchorage

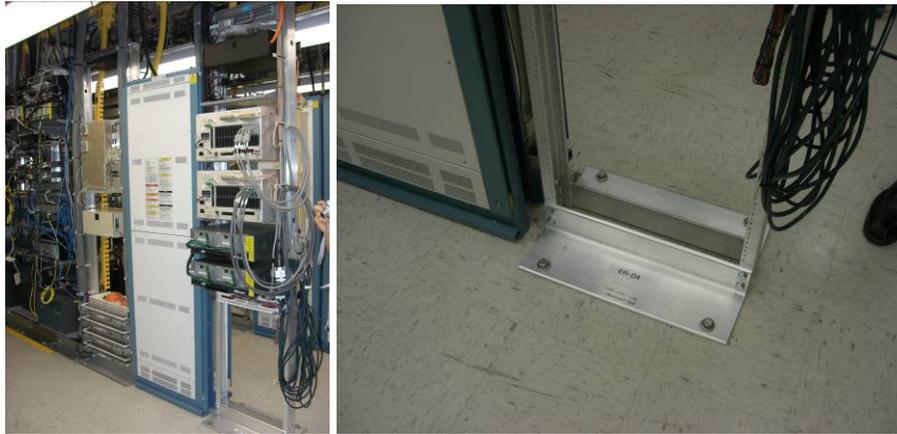
Figure 3-80. Telecommunications equipment at BDF and its anchorage

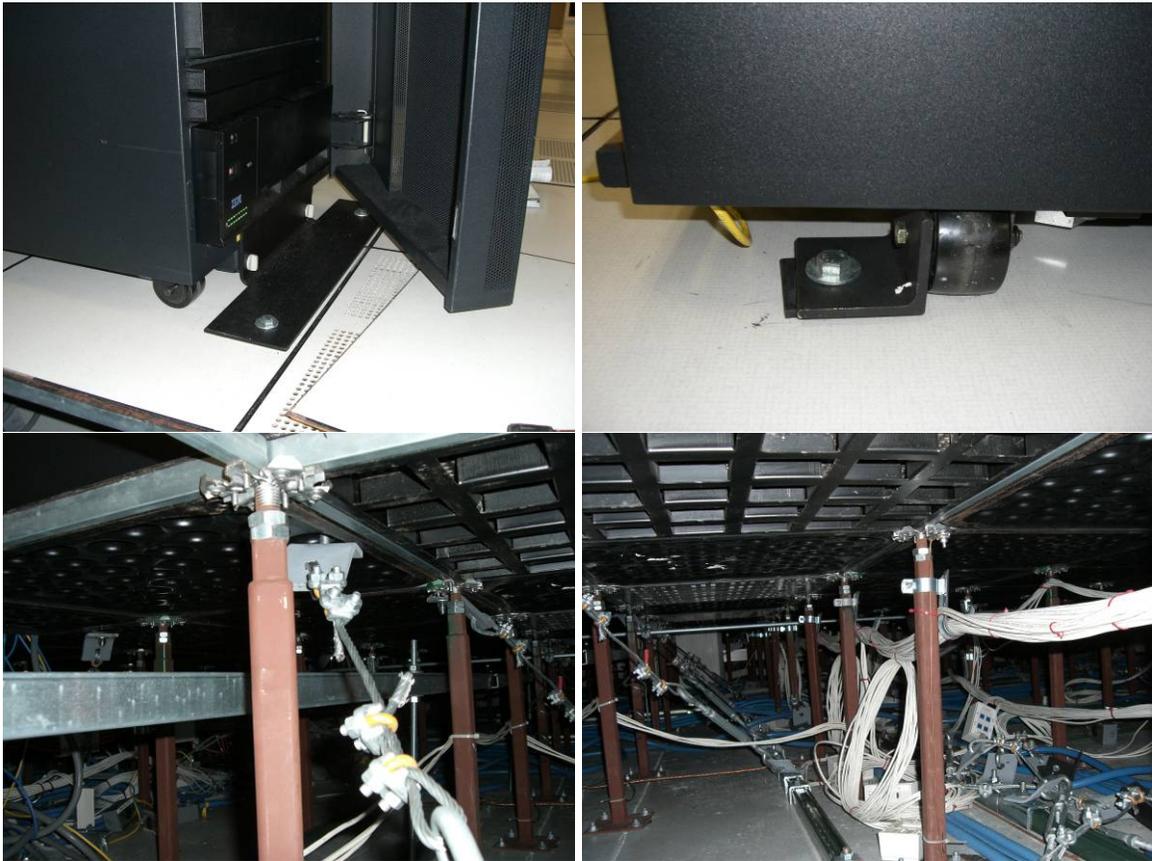
Figure 3-87. System of tethering computer equipment to slab below raised access floor in BDF CPU room

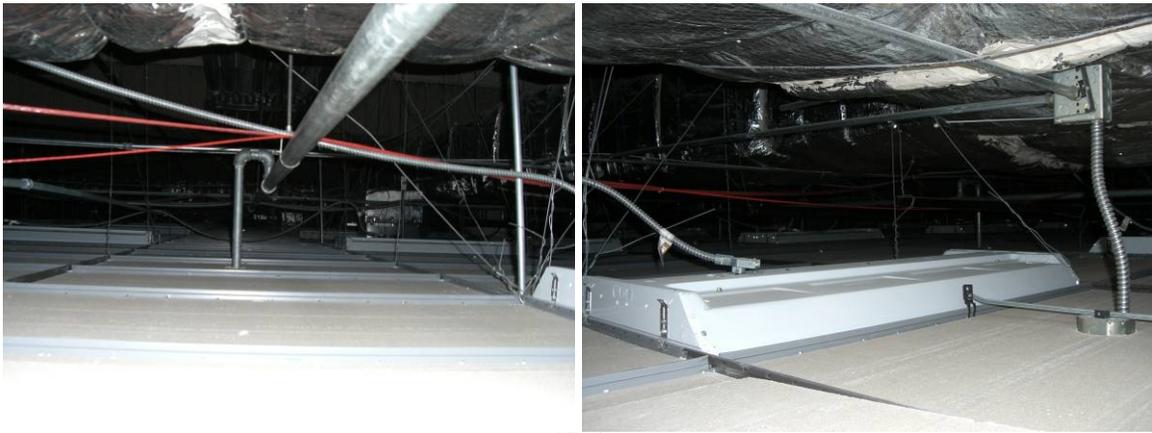
Figure 3-88. Ceiling in the BDF CPU room with compression struts, splay wires, and safety wires on light fixtures

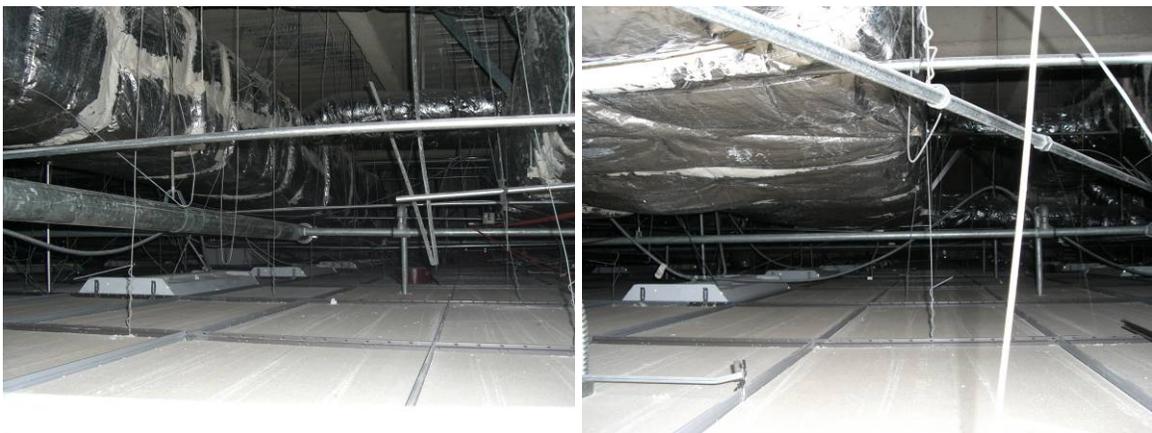
Figure 3-89. Ductwork and sprinkler pipe at BDF CPU room

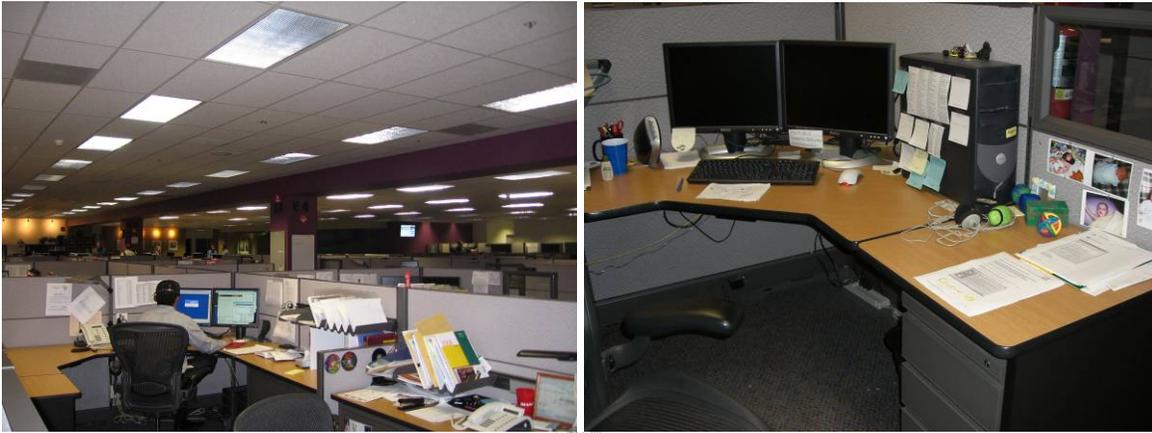
Figure 3-90. BDF helpdesk center and apparently unsecured computer equipment

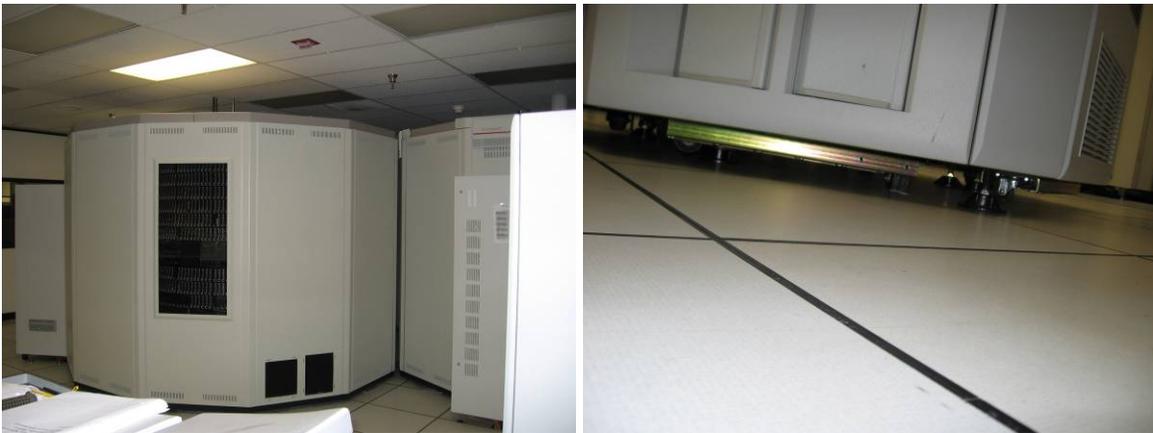
Figure 3-92. Apparently unrestrained BDF tape silos

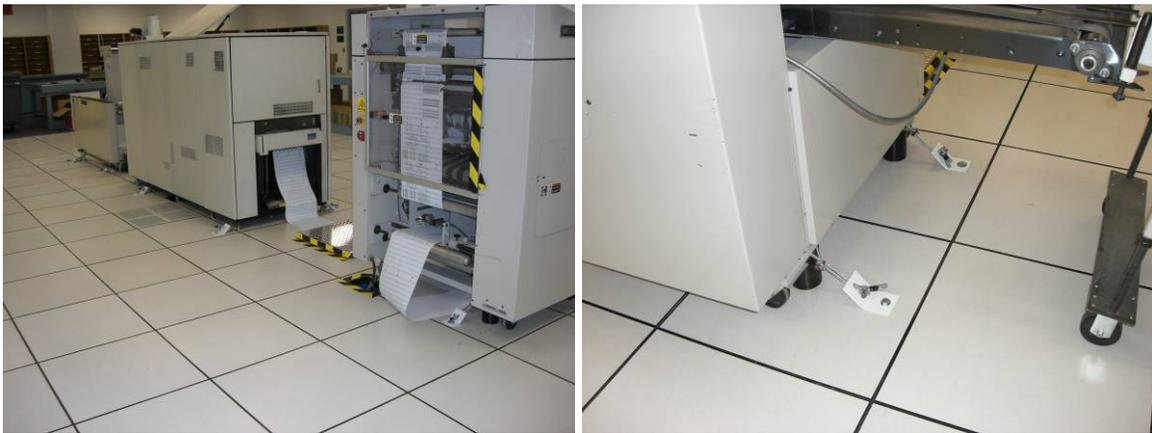
Figure 3-93. Document handling equipment in BDF restrained to raised access floor

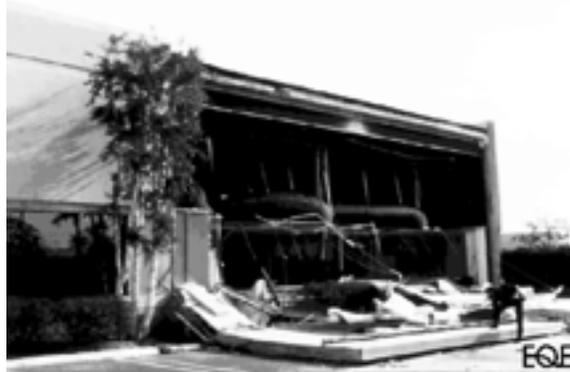
Figure 3-98. Damage to tilt-up construction during the Northridge earthquake – this section of tilt-up wall pulled away from the rest of this high-technology company's corporate computer center. There was severe damage to the interior as a result. Source: EQE International (1994).

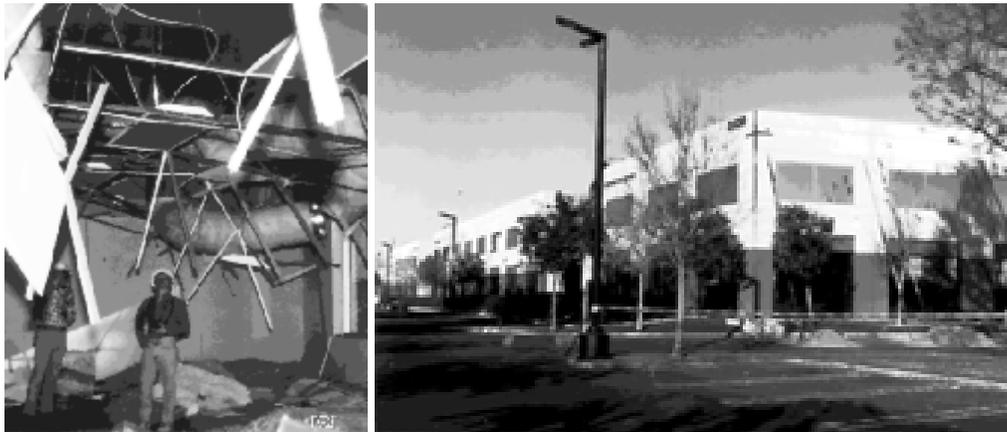
Figure 3-99. Damage to tilt-up construction during the Northridge earthquake – The wall of this office tilt-up nearly fell away during the earthquake. It has been braced, and a temporary tie to the adjoining wall has been installed until more permanent repair can be made. The interior of the second floor was almost completely destroyed (as shown in the photograph on the left). Source: EQE International (1994).
