THE LOMA PRIETA, CALIFORNIA, EARTHQUAKE OF OCTOBER 17, 1989:
STRONG GROUND MOTION AND GROUND FAILURE

MARINA DISTRICT

PERFORMANCE OF EMERGENCY-RESPONSE SERVICES
AFTER THE EARTHQUAKE

By Charles R. Scawthorn and Keith A. Porter, EQE Engineering and Design; and
Frank T. Blackburn, PWSS Co., Ltd.

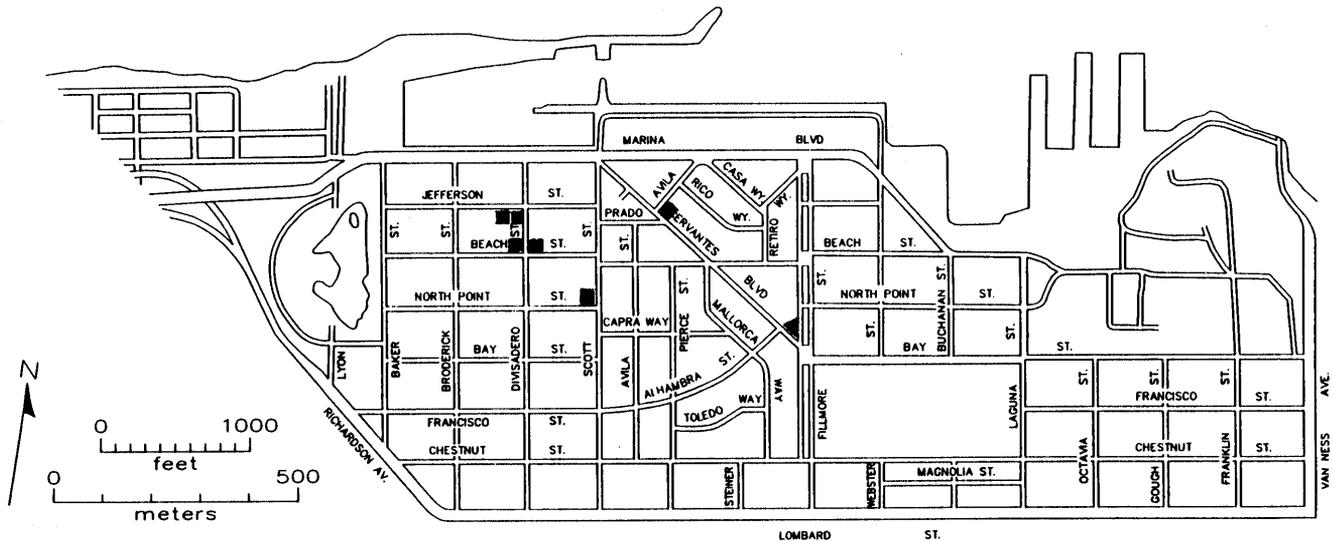
Figure 7.—Marina District, showing locations of collapsed buildings (dark areas). Base map from U.S. Geological Survey (1990).

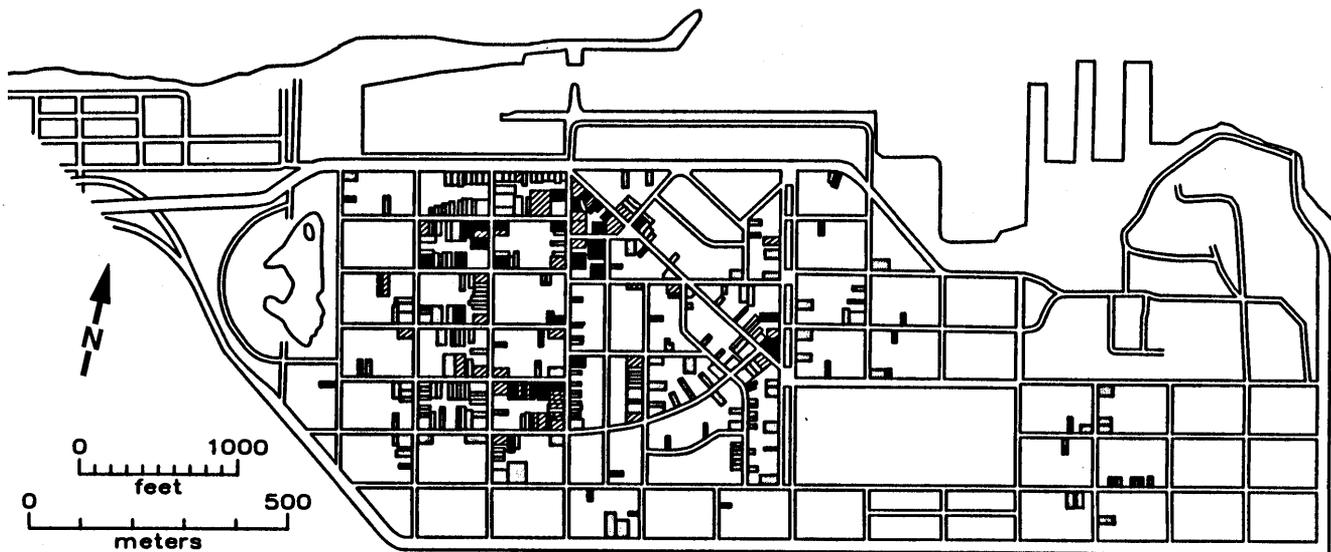
Figure 8.—Marina District, showing locations of damaged buildings. From Seekins and others (1990).

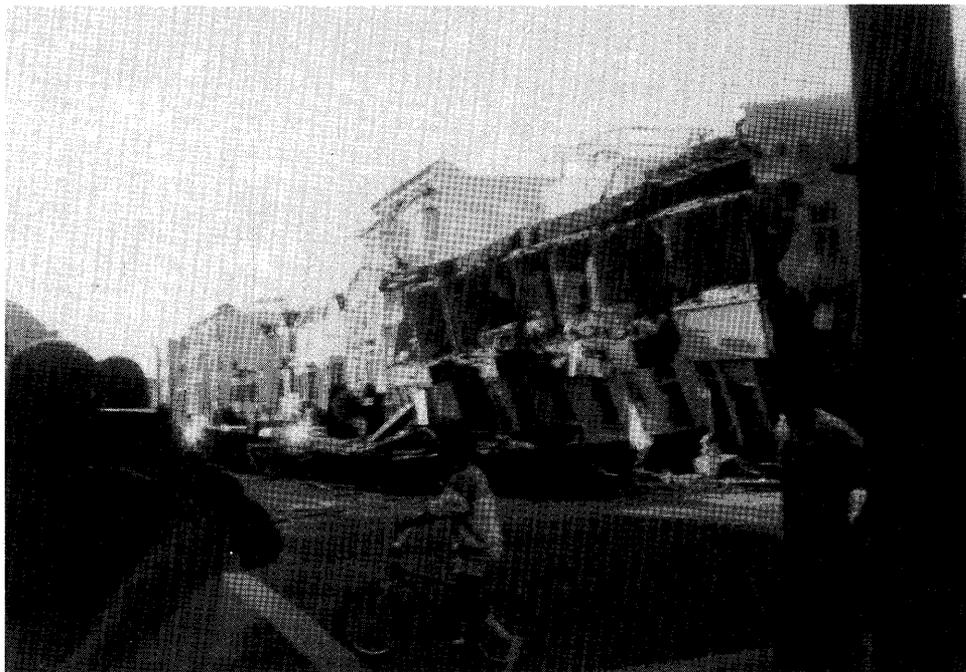
Figure 12.—Collapsed building at 3701 Divisadero shortly after the earthquake. SFFD units had not yet arrived. Note dust or smoke from incipient fire at right. Photograph taken at about 5:20 p.m. October 17, 1989, from intersection of Beach and Divisadero Streets; view northwestward.

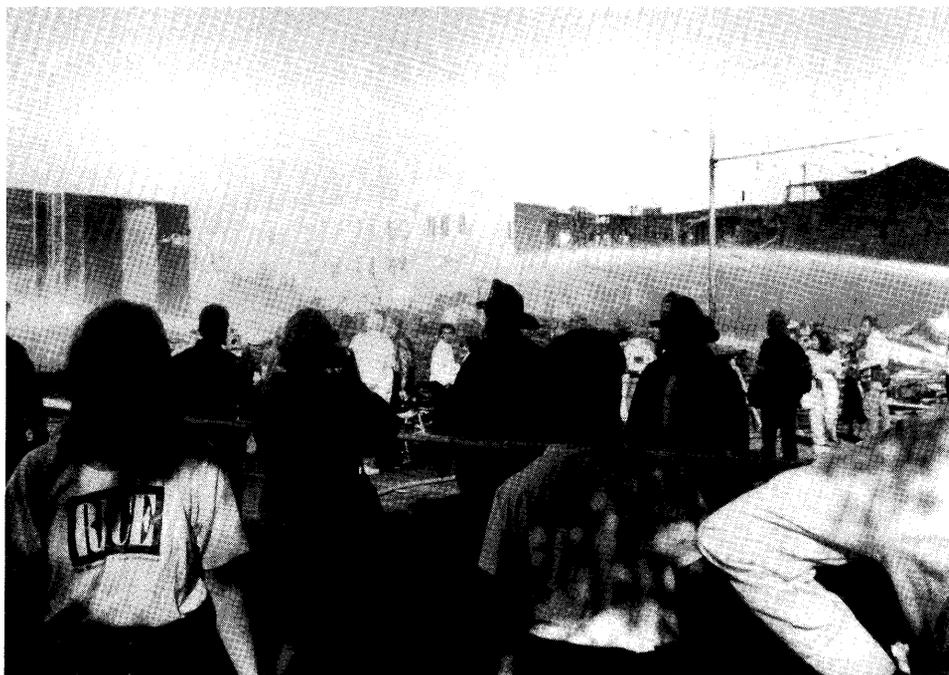
Relief began to come for the initial responders late into the night. Engine 41 was relieved around 11:30 p.m., and Engine 10 around midnight. Firefighters continued mopping-up operations for several days (fig. 15). The fire damaged seven structures, destroying four buildings containing 33 apartments and flats (Sanborn Map Co., 1988): 3701 Divisadero (21 apartments), 2130 Beach (12 apartments), 3717-19 Divisadero (2 flats), and 3723-25 Divisadero (2 flats). SFFD estimates place the losses from this fire at \$7.4 million (fig. 16).

Figure 15.—Mopping-up operations on fire. Photograph taken October 18, 1989, from southeast corner of Beach and Divisadero Streets.

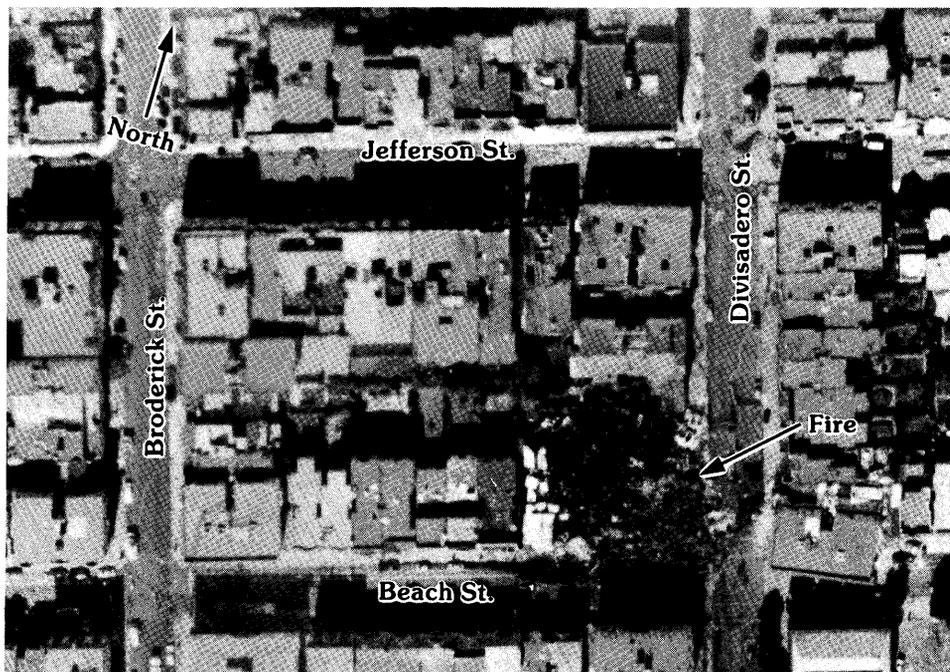
Figure 16.—Northwestern part of Marina District, showing area near Beach and Divisadero Streets. Fire destroyed corner building, another immediately to west, and two more immediately to north.

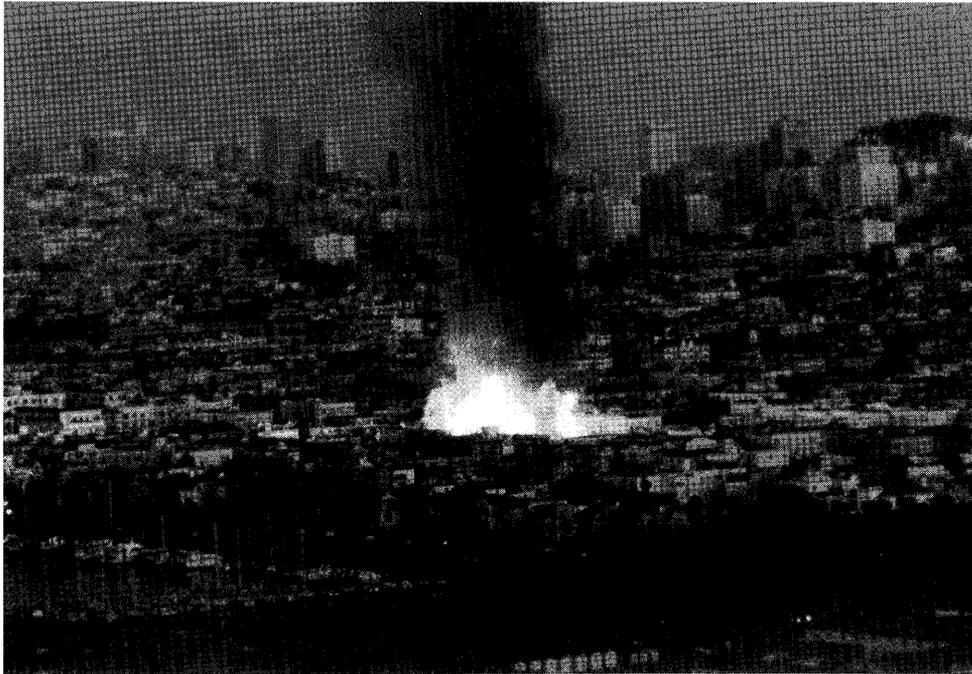
At 6:33 a.m., the fire was still out of control (fig. 17), and the police were having trouble evacuating civilians. At 6:35 p.m., Chief Brophy radioed the communications center. Again, the transmission is fragmented, but its urgency is apparent: "The situation down here in the Marina is devastating. We've 20 or 30 buildings here off their foundations . . . this is a national . . . police cannot handle the sit. . . ."

Figure 17.—Fire in the Marina District. Photograph by Martin Klimek, *Marin Independent Journal*, taken shortly after sunset October 17, 1989; view southeastward.
