Utility Performance Aspects, Liquefaction Study, Marina and Sullivan Marsh Areas, San Francisco, California

Charles Scawthorn, Keith Porter and Mahmoud Khater
EQE International
San Francisco, CA 94104

ABSTRACT

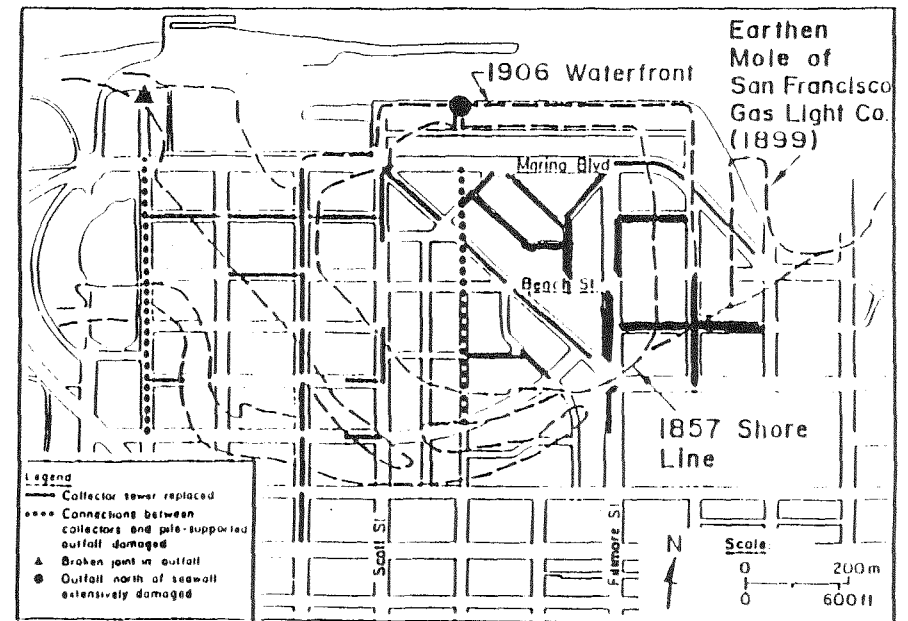
Figure 2
DAMAGED AND REPLACED SEWERS IN
THE MARINA FOLLOWING LOMA PRIETA

Sewer Extensive damage resulting from the 1989 Loma Prieta earthquake was incurred by sewers in the Marina District. Most of the damage was incurred by "Old Style VCP," but there was some damage to brick sewers. Considerable damage occurred at the connections between buried sewers and those on pile supports. Minor damage in the form of joint separation was noted for cast-in-place sewers. The Clean Water Program is replacing nearly 6,500 feet of sewers in the Marina at a cost of nearly \$1,700,000. Figure 2 shows sewers that were damaged in the Marina in 1989. The criteria used by the City of San Francisco for sewer replacement in the Marina District was to replace the whole run if two or more repairs were required within a single sewer run between manholes, which is a very economical approach.

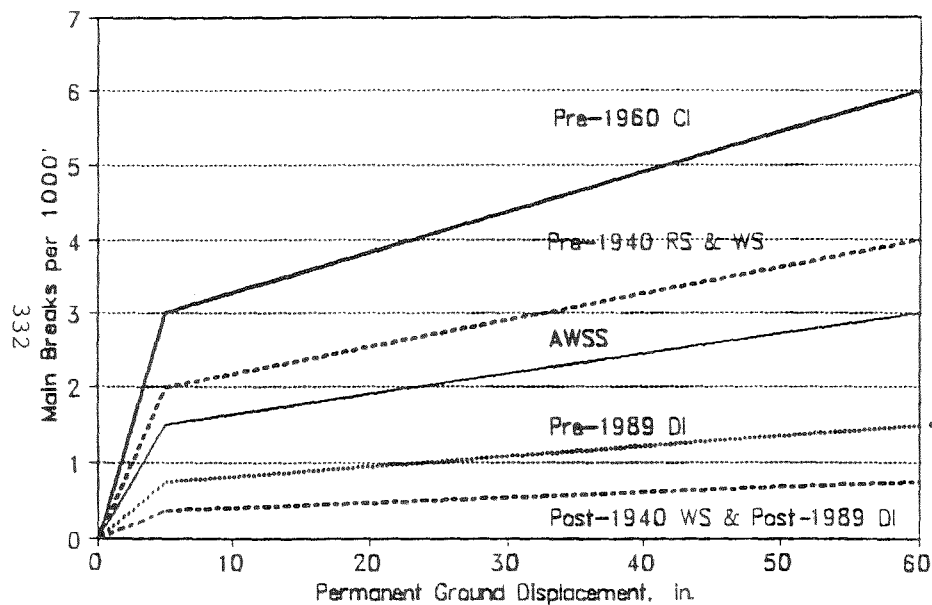
Figure 3
ESTIMATED UNDERGROUND PIPE
DAMAGE FUNCTIONS

Breakage in pre-1940 MWSS cast iron pipe was correlated with amount of ground movement. These relationships were then factored to produce damage functions for other classes of pipe. Damage resulting from interaction with other buried facilities was also estimated. Three modes of damage were identified: differential settlement, vertical settlement, and lateral spreading. Differential settlement was particularly associated with pile-supported sewers. Experience in the Loma Prieta Earthquake indicates that high relative settlements can be expected at sewers supported on piles. Pipes crossing over or through

these sewers are supported at the sewer and pushed down on either side by surrounding soil settlement. The consequent bending can fracture the pipe. Break rate functions were developed for each material, as a function of permanent ground displacement, shown in Figure 3.

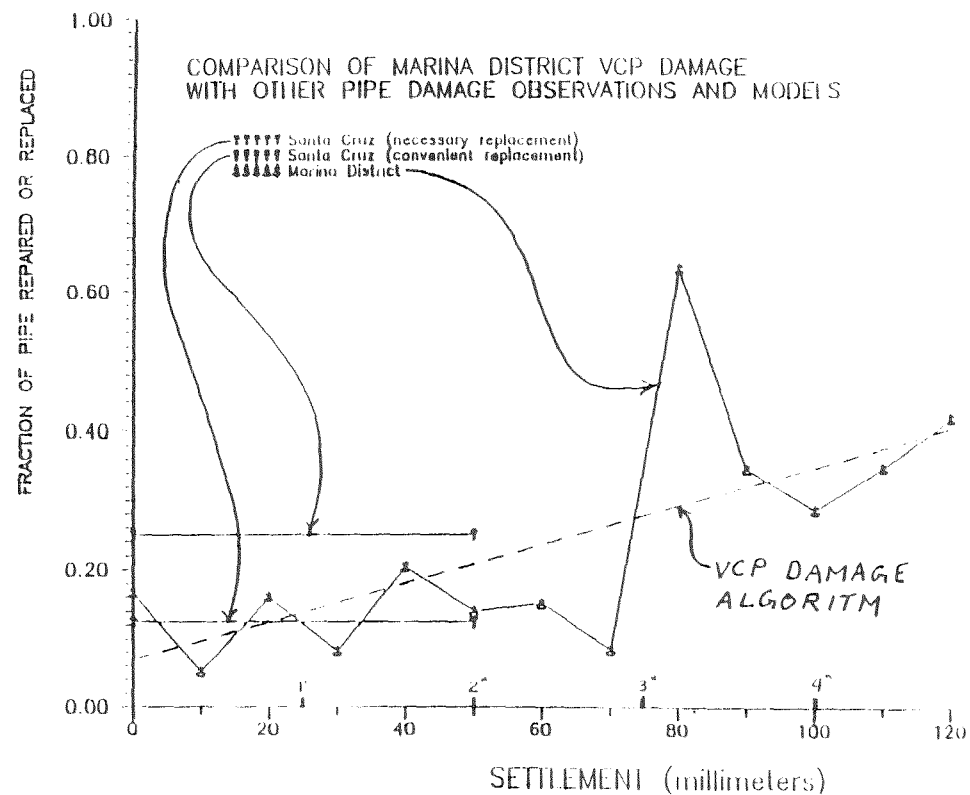
Figure 4
COMPARISON OF MARINA DISTRICT
VCP DAMAGE WITH SANTA CRUZ

Initially, it was hypothesized that the pipe damage rate would show positive correlation with average ground strain, the rate of change of absolute permanent ground deformation. Microzone plots of strain versus damage rates, however, did not verify this. It is assumed, however, that higher damage rates would occur at ground movement interfaces, such as 4th Street and Brannan Street in Sullivan Marsh, as was experienced with water mains in 1906. Next, it was hypothesized that the pipe damage rate would correlate positively with absolute permanent ground deformation. The premise was that local ground strains were much higher than average strains. Local strains would correlate to absolute deformation. Pipe damage rates would then correlate to absolute deformation. The sewer repair and replacement map, Figure 2, was laid over the estimate ground settlement, for the Marina District. Total sewer lengths of repairs and replaced Old Style VCP were measured for each settlement range zone, and damage rates were calculated. A plot of these results is shown on Figure 4.

It is worthwhile to compare the resulting curve with information from another source to assess its validity. In Santa Cruz, the most extensive damage due to the 1989 Loma Prieta Earthquake occurred in liquefiable areas, particularly along the San Lorenzo River. The City of Santa Cruz televised 40,000 feet of sewer pipe in those high water pipe damage areas. Of that total, 5,000 feet were identified as needed to be replaced. Consideration is being given to replacing 10,000 feet to avoid replacing small sections of pipe. The resulting necessary replacement rate is 12.5 percent. Those replacements are plotted on Figure 4, showing similar repair rates to those encountered in the Marina District.
