## Loss Estimates for Large Soft-Story Woodframe Buildings in San Francisco

Keith Porter<sup>1</sup> and Kelly Cobeen<sup>2</sup>

### ABSTRACT

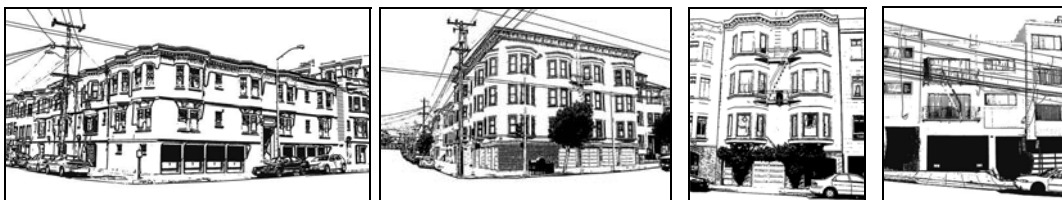
**Figure 1.** Representative index buildings 1-4 (from left to right) studied as part of the CAPSS project.

Plans and street front elevations for candidate representative buildings were compiled by San Francisco Bureau of Building Inspection for consideration, and a design charette was held to get input on selection of buildings, retrofit approaches, and performance expectations. Using this information, four buildings were selected for study. See Figure 1 for illustrations of the buildings. It was decided to use two corner buildings and two mid-block buildings. Variables chosen included the number of stories, the size of the building footprint, and the construction materials. Each of the index buildings has a soft story ground story, accommodating parking and storage areas, while the upper stories have residential units with a significant amount of interior partition wall. The soft story ground story could alternatively have housed commercial space; the use of the ground floor does not have a great impact for the buildings and retrofits chosen. Table 1 summarizes the four index buildings.

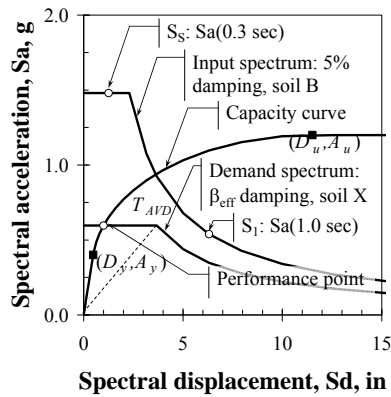
Figure 6. Capacity spectrum method of structural analysis as intended for HAZUS

We originally intended to use the HAZUS Advanced Engineering Building Module (AEBM, NIBS and FEMA 2003) to estimate structural response, damage, and loss for the soft story buildings. The methodology uses the capacity spectrum method to estimate structural response (CSM, ATC 1996). CSM is a pseudostatic nonlinear procedure that idealizes a building as a single-degree-of-freedom nonlinear damped harmonic oscillator with a 3-part pushover curve: linear up to a yield point ( $D_y, A_y$ ), perfectly plastic past an ultimate point ( $D_u, A_u$ ), and a portion of an ellipse between the two. The effective damping ratio is estimated as the sum of an elastic damping ratio and a fraction of the hysteretic damping, where the fraction,  $\kappa$ , is a function of

earthquake magnitude (and indirectly, duration) to reflect pinching of the idealized hysteresis loop. Structural response is parameterized as the spectral displacement ( $S_d$ , in inches) and spectral acceleration ( $S_a$ , in g's) of the idealized oscillator. It is estimated as the point—called the performance point—where the pushover curve intersects the idealized demand spectrum with the same effective damping ratio  $B_{eff}$ . The idealized demand spectrum has two parts: a constant-acceleration portion and a constant-velocity portion, both adjusted to account for site soil amplification ( $F_a$  in the constant-acceleration region and  $F_v$  in the constant-velocity region) and effective damping ( $R_A$  in the constant-acceleration region and  $R_V$  in the constant-velocity region). Figure 6 summarizes the methodology. Equations (1) through (7) give the equations for the demand spectrum. In Equation (6),  $Area$  is the area of one idealized full hysteresis loop whose upper right hand corner is the performance point, and  $B_E$  is the elastic damping ratio. See Porter (2009) for the pushover curve, especially for the ellipse portion between yield and ultimate.
