Analysis of Simultaneous Operational Failure of Critical Facilities due to Earthquake, for a California Utility

Prepared by
CALIFORNIA INSTITUTE OF TECHNOLOGY

**Aug 7, 2006
Rev 1**

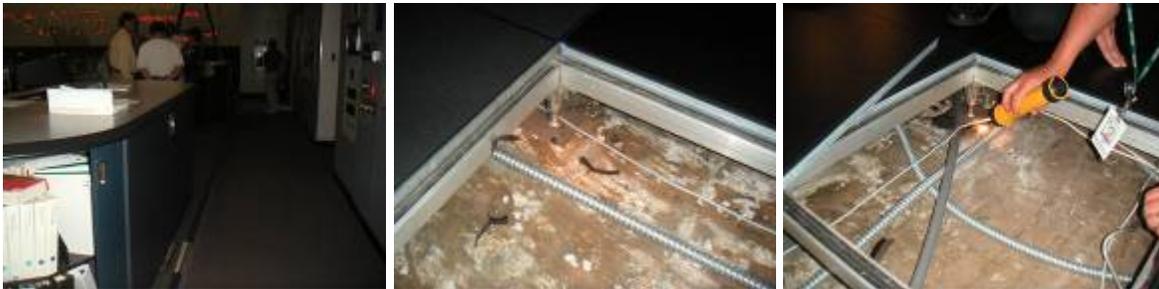
slab, in others possibly secured by mastic (Figure 3-3). Such glue is intended only to hold the pedestals during installation, not to secure them for the long term. It is thought that concrete surface dust and other defects result in low shear capacity. Mechanical anchors are preferable. All raised access floors appeared to have stringers connecting pedestals—a desirable feature. The room contains three computer consoles and a display board. We were told that one of the consoles provides a backup for either of the other two. The consoles appeared to have no positive restraint against sliding (Figure 3-4), meaning that in strong shaking they could slide or overturn. This is a potential weak link at this facility.

Figure 3-3. Grid control room and pedestals supporting its 3-in raised access floor

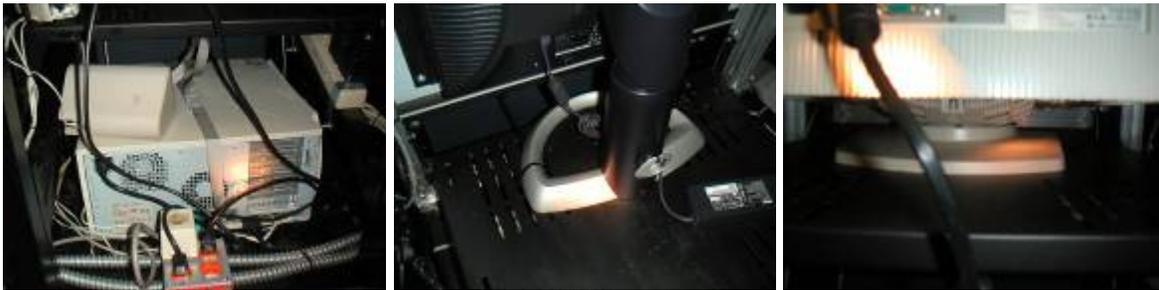
Some of the computer monitors and system units (the boxes that house the disk drives, system board, central processing unit, etc.) in the consoles were observed to be restrained against sliding, and some appeared to be unrestrained (Figure 3-5). Lack of restraint tends to increase the probability that the component will slide, overturn, and possibly cease to operate in the event of an earthquake. Unrestrained computers and monitors could be a weak link at this facility. The large display board contains a number of liquid crystal displays, which appeared to be well secured to a Unistrut steel frame, itself apparently anchored to the floor and wall (Figure 3-6).

Figure 3-5. Some but not all computer equipment in grid control room appeared to be restrained

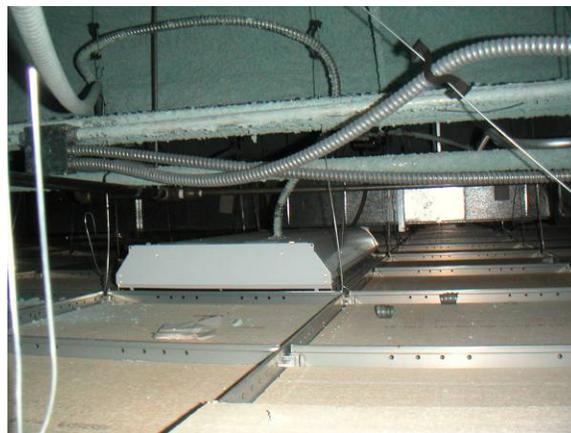
appeared to lack safety wires secured to the slab above (Figure 3-11). This is primarily a life safety hazard, although in the 1983 Coalinga earthquake, falling light fixtures caused damage to equipment below (EQE Inc., 1986). The room is protected by a Halon system for fire suppression, and the Halon tank is secured to the wall (Figure 3-12).

Figure 3-11. Some light fixtures in the main computer room appeared to lack safety wires

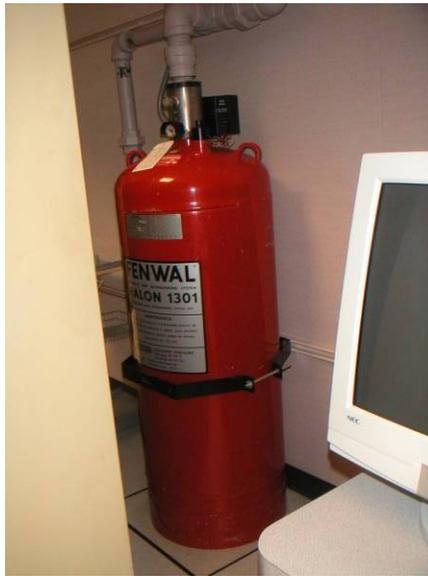
Figure 3-12. Halon tank in main computer room appeared to be secured to the wall

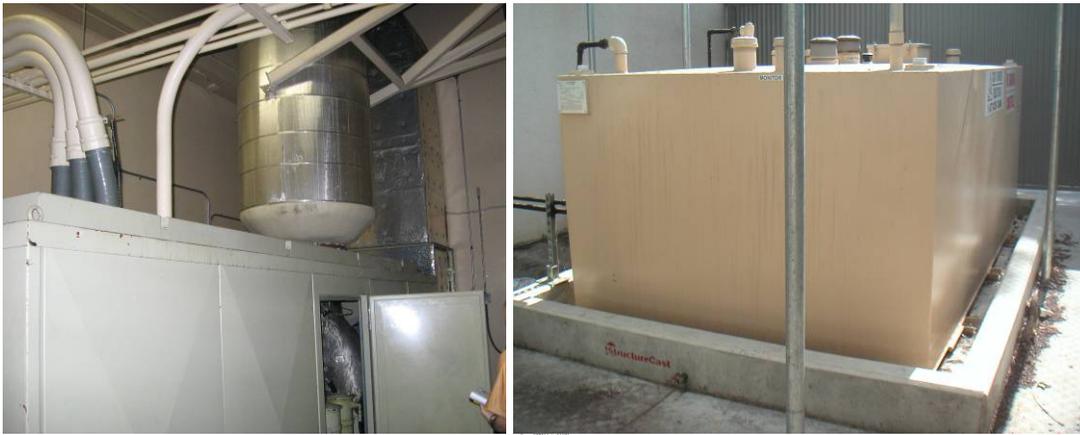
Standby emergency generator. A 800 kW Saturn Solar generator is installed at the facility, which we were told is of powering the entire GCF. It is supplied from a 2000-gallon tank outside the building (Figure 3-13), which is anchored to the slab, and capable of supplying the generator with 50 hr of fuel at 40 gal/hr. However, the fuel is delivered to the generator via a combined day tank and fuel pump (Figure 3-14). The fuel pump and day tank are not secured to the floor, which substantially increases the probability that in a strong earthquake they would slide and break the attached piping, itself secured to the wall, rendering the generator inoperative and possibly spilling diesel fuel (Figure 3-15). The generator requires batteries to power its starter motor. Although the battery rack is secured to the floor, the batteries lack spacers to prevent them from sliding within the rack (Figure 3-16), which increases the probability that movement of the batteries would break the conductors between individual cells, which would prevent the batteries from powering the starter motor, and prevent from the generator from starting. The generator is tested monthly, a desirable feature that mitigates the probability of operator failure or undetected equipment damage. However, the day tank's lack of anchorage and the battery rack's lack of spacers appear to be important weak links in the GCF's provision for on-site electric power in the event of the loss of off-site power.

Figure 3-13. GCF emergency generator (left) and its fuel tank (right)

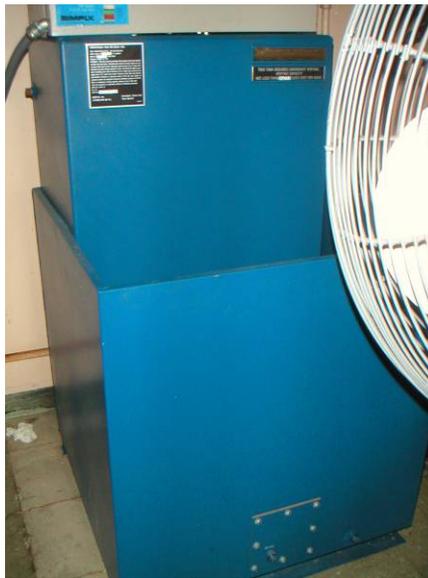
Figure 3-14. GCF combined generator day tank and fuel pump, apparently not anchored to the slab

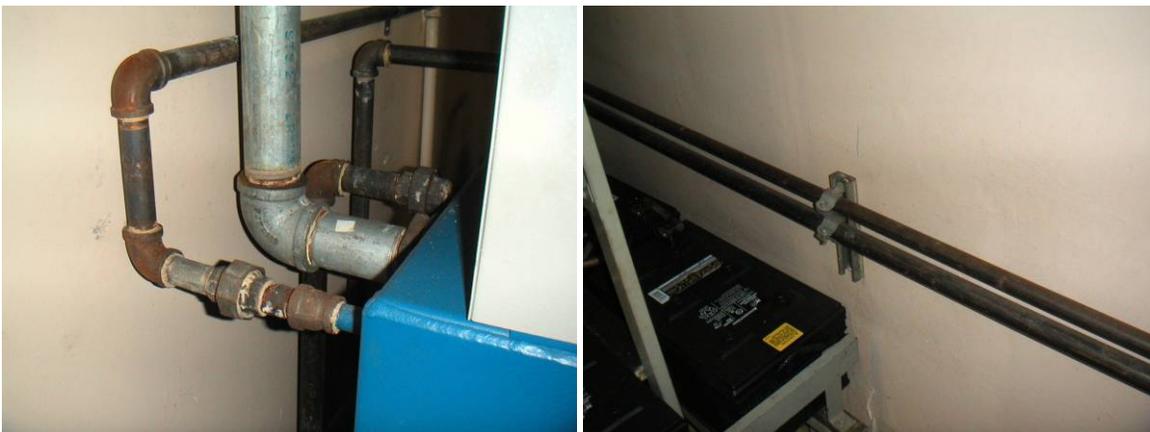
Figure 3-15. Piping attached to GCF generator day tank

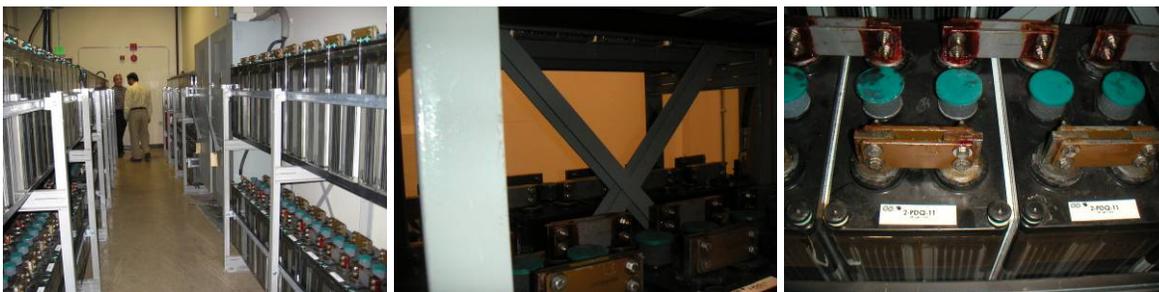
Other electrical equipment in electrical building. Uninterruptible power supply (UPS) equipment and other electrical equipment are housed in a small structure adjacent to the main building. The UPS battery racks are well anchored to the floor slab, have longitudinal diagonal braces and batteries are restrained from falling off the rack and supplied with spacers between batteries, all desirable features (Figure 3-17). Cabinets holding the transfer switches, as well as all other controls, breakers, and transformers whose anchorage was examined, appeared to be anchored to the floor slab (Figure 3-18). While overhead cable trays in at least one portion lacks lateral restraint, the run is braced in each direction by an abutting wall (Figure 3-19). There are some pendant lights in this room of a type that have collapsed in past earthquakes, but again, this mostly life-safety concern is mitigated by the fact that the room is not normally occupied (Figure 3-19). A radio tower on the top of this electrical building was not examined for seismic resistance (Figure 3-20).

Figure 3-17. GCF battery racks

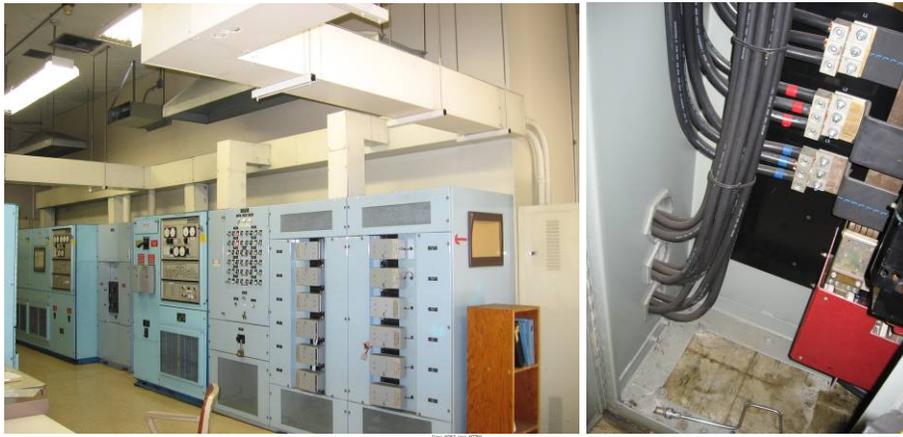
Figure 3-18. Electrical cabinets appeared to be anchored to floor slab

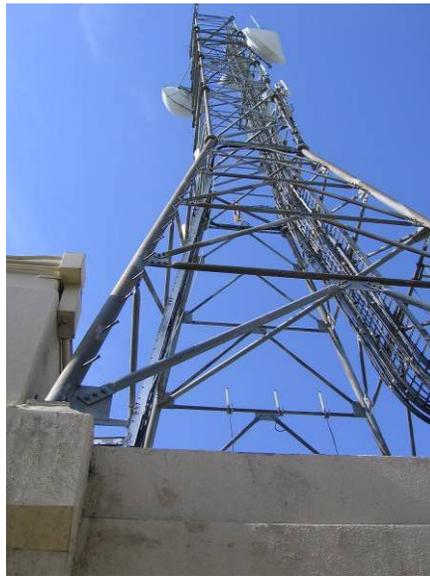
Figure 3-20. Radio tower at GCF

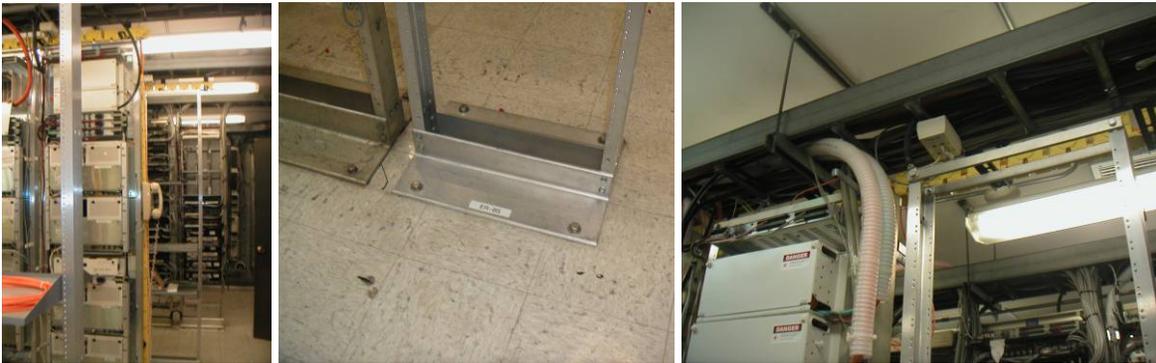
Telephone switching equipment. Telephone switching equipment in the telecommunications room appeared to be anchored at the base although without apparent bracing at the top (Figure 3-21). Cable trays lacked sway bracing, but were generally not in long straight runs, and did not appear to be particularly heavily loaded or capable of falling off their supports (Figure 3-22).

Figure 3-21. Anchorage of DPF telephone switching equipment

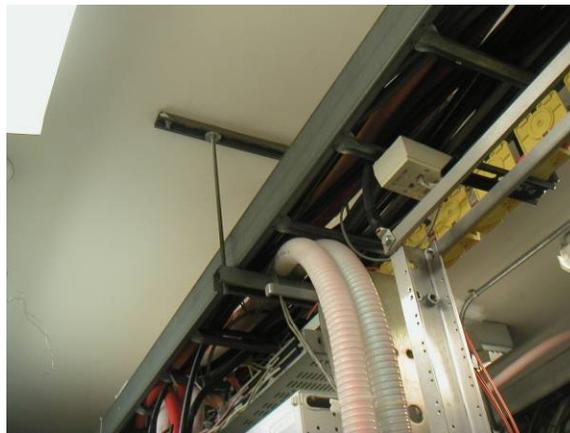
Figure 3-22. A DPF cable tray in a telephone switch room

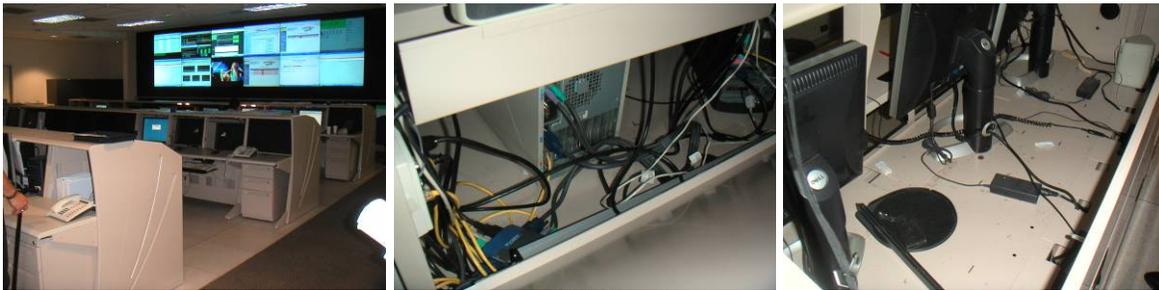
Information Technology Operations Center (ITOC). Computer equipment in this room is mounted in long consoles, largely without straps or other means of preventing sliding or overturning of the system units or monitors (Figure 3-23). There appears to be no restraint of the consoles themselves to prevent sliding or overturning. Other furnishings in the room such as tall filing cabinets lack seismic restraint (Figure 3-24). Raised access floor in this room is on heavy 2-ft pedestals, but each pedestal appeared to be secured to the slab below by two

Figure 3-23. Consoles containing apparently unrestrained computer system units and monitors

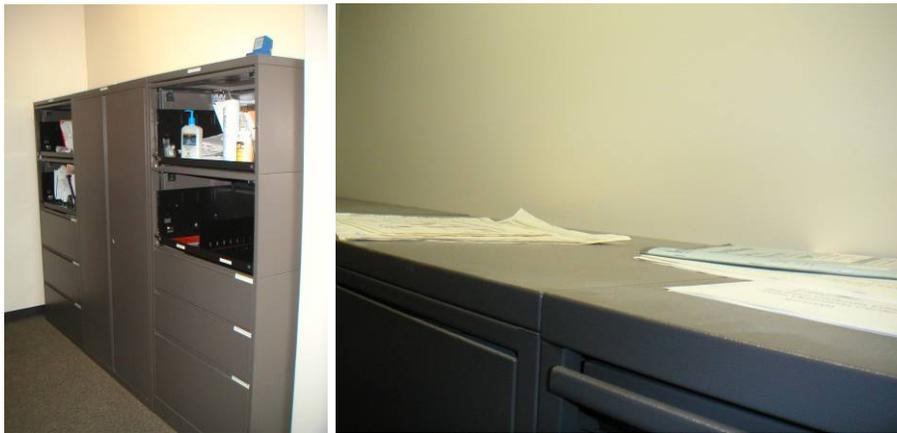
Figure 3-24. Apparently unrestrained tall furnishings in DPF ITOC room

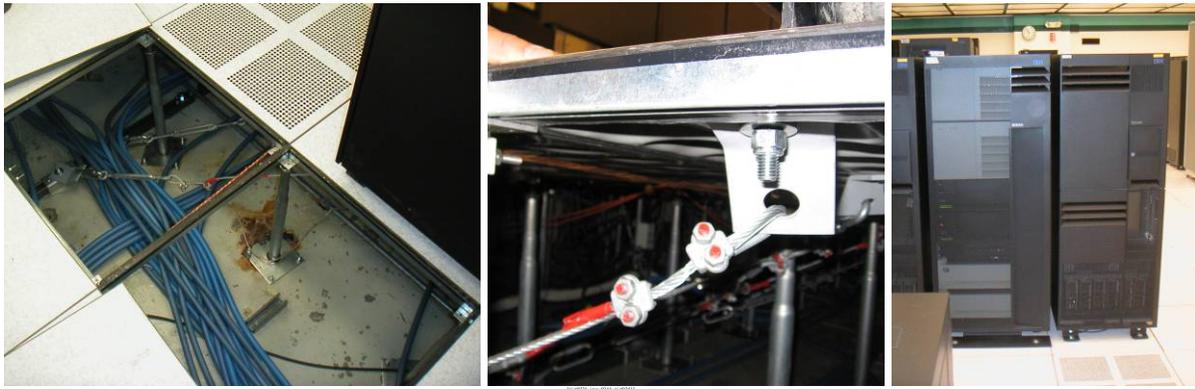
Figure 3-27. System of tethering equipment in CPU rooms 1 and 2

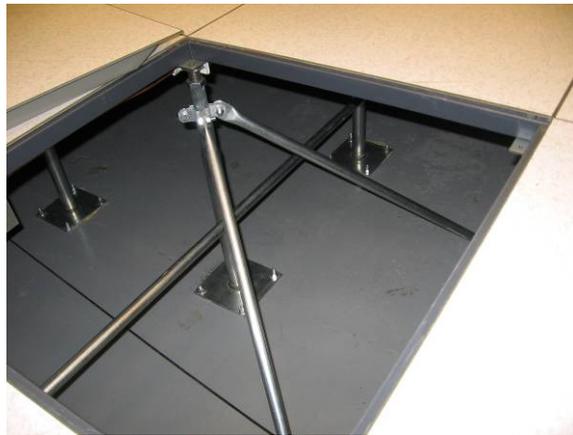
Figure 3-29. Bracing on raised access flooring in part of CPU room 2

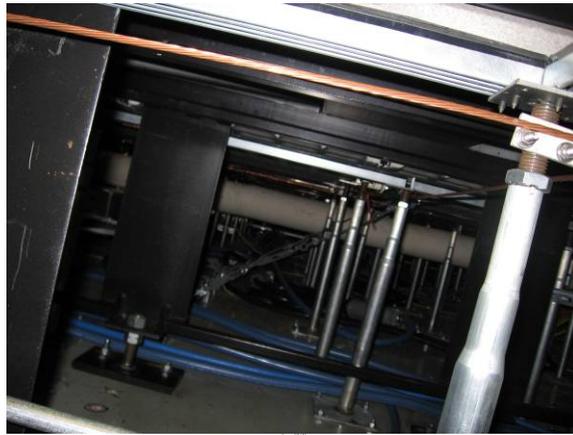
CPU rooms 1 and 2. Suspended ceilings examined here lack compression struts, and it was unclear whether light fixtures in the ceiling had secure, independent safety wires, which if absent would indicate a higher probability that light fixtures could fall, threatening life safety and endangering computer equipment. Computer equipment cabinets here are tethered at four corners to the slab below by various systems: slack steel cable with turnbuckles for tension adjustment, anchored to Unistrut members bolted to the slab below and secured by various means to the cabinet above (Figure 3-27); or by steel frames (Figure 3-28). Raised access floors in CPU room 2 are braced on one side of the room (Figure 3-29), although not on the other. Computer cabinets are all secured to the slab below by similar means as in CPU room 1, i.e., tethers or rigid frames, although it appears that the rigid frames in some cases rely on relatively long unbraced lengths of bolt (Figure 3-30).

Figure 3-30. Seismic restraint of equipment in CPU room 2

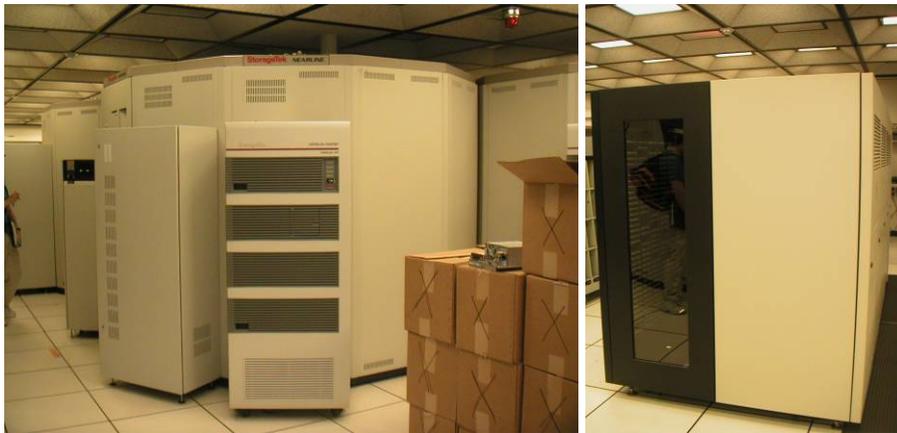
Tape library. This room houses five cylindrical tape silos³, as well as some smaller units that perform the same function (Figure 3-31). The tape silos are not secured to the floor, resting on leveling devices (Figure 3-32); in strong shaking, conduit attached to the tape silos from above (we were told these were for Halon supply; see the pipe above the cylindrical tape silo on Figure 3-31) would provide limited restraint, although these conduits are probably not intended to serve such a purpose. The raised access floors themselves lack diagonal bracing, and stand on slender pedestals secured to the slab with two shot anchors per pedestal (Figure 3-33). Halon tanks in this room are secured to the wall, and Halon pipes appeared to be at least partially braced (Figure 3-34). The lack of seismic restraint for the raised access floors and tape silos may represent a weak link at this facility.

Figure 3-31. Tape silos at DPF

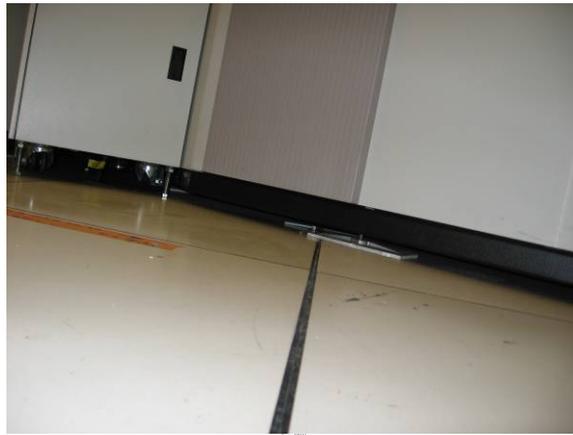
Figure 3-32. Levelers under DPF tape silo

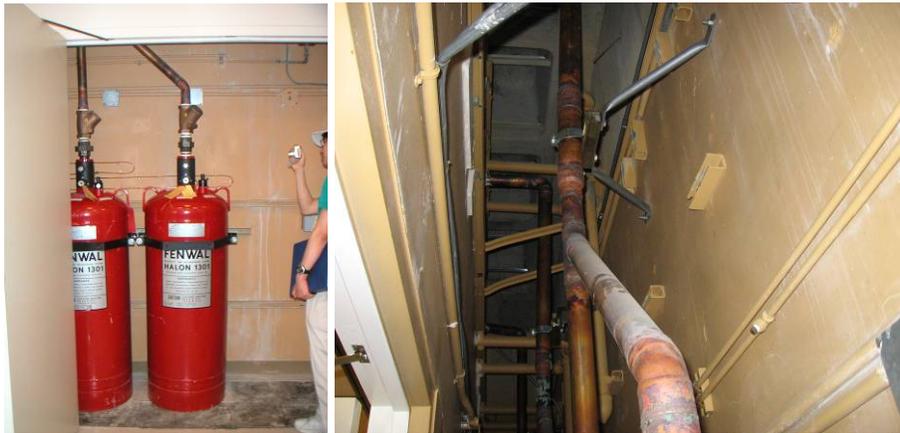
Figure 3-34. Halon tanks and pipe in DPF tape silo room

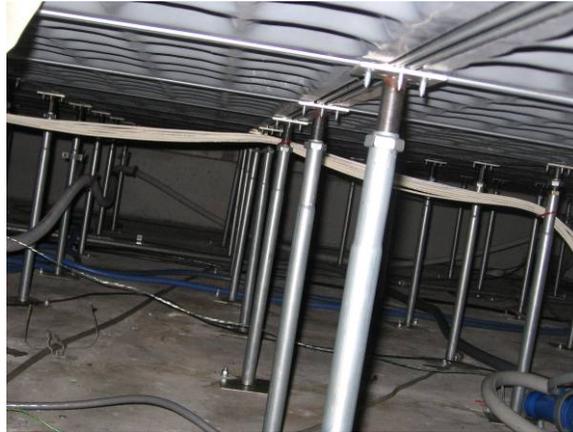
flooring without diagonal bracing and limited anchorage to the slab below (two anchors per pedestal, as opposed to four; Figure 3-36). The lack of seismic restraint for the raised access floors and printers seems to represent another weak link at this facility.

Figure 3-36. Apparently unbraced raised access floor in DPF printer room

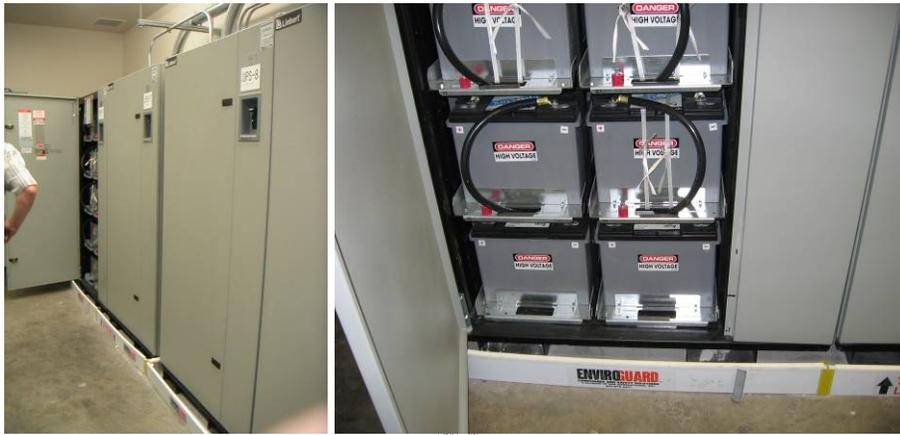
UPS equipment. The uninterruptible power supply (UPS) system, comprising two banks of two redundant systems (5 and 6, 7 and 8; Figure 3-37) appear to be anchored to the slab although not braced at the top (Figure 3-38); batteries appeared to be generally, but not always, secured on their racks, as shown in Figure 3-37. The cabinets that house the rectifiers, inverters, and other electric equipment needed to convert between outside power and UPS power appeared to be anchored to the slab (Figure 3-39). The electrical conduit between the batteries and these cabinets were supported on hangers that appeared to be braced to the wall (Figure 3-40).

Figure 3-37. DPF battery racks

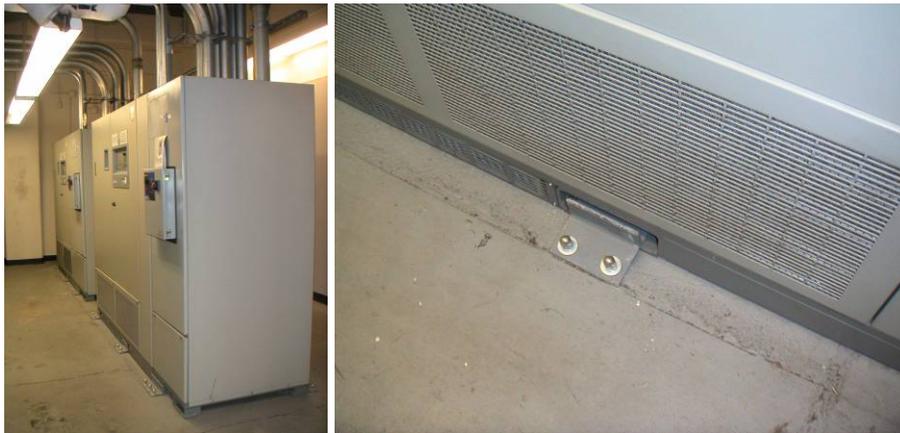
Figure 3-39. UPS cabinets appeared to be anchored

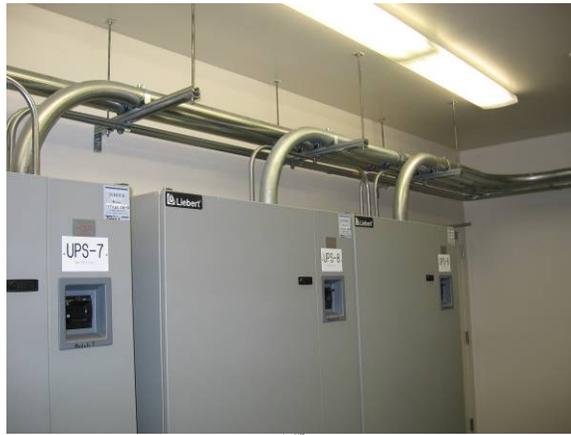
Figure 3-40. UPS electrical conduit hangers in DPF apparently braced to the wall

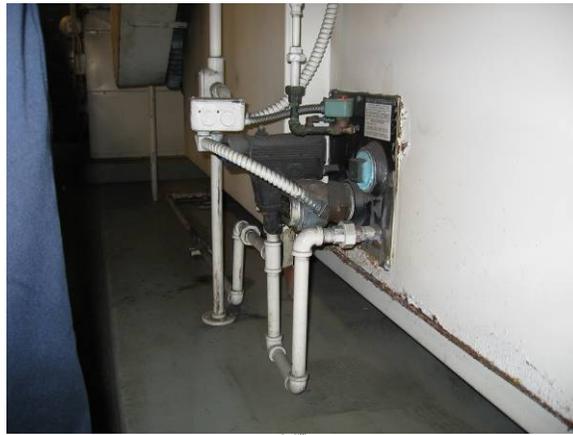
are on vibration isolators without seismic snubbers (Figure 3-42). (Seismic snubbers are metal fixtures attached to the slab next to a vibration-isolated mechanical device to restrain the device's lateral movement; an example is shown in Figure 3-43). The AHUs are rigidly attached to piping that could be damaged by excessive displacement of the AHU in an earthquake (Figure 3-44), which is another issue that tends to raise the probability of operational failure. Note that two of the four AHUs are needed. Lack of seismic restraint for these AHUs is a potential weak link at this facility.

Figure 3-44. Piping rigidly attached to an air handling unit in DPF

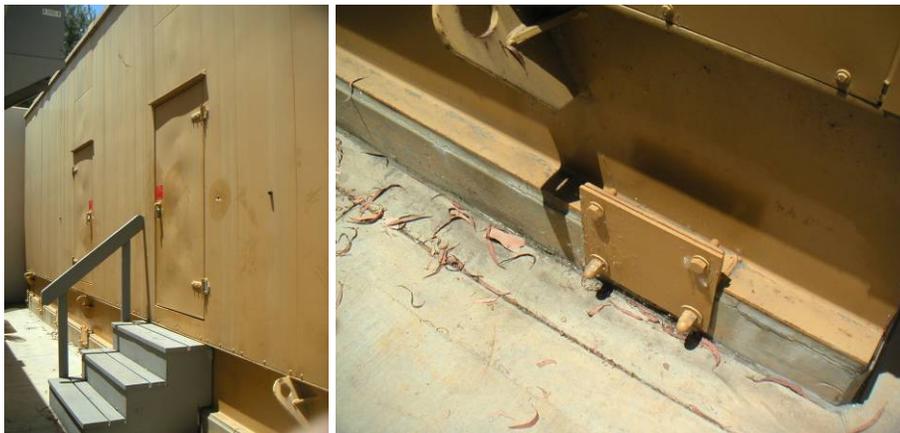
Emergency generator. A diesel generator is located outside the building within an unroofed enclosure. The generator has a belly tank and a 10,000 main fuel tank capable of supplying the facility with electric power for 4 to 8 days. The generator, its fuel tank, and switchgear appear to be well anchored (Figure 3-45, Figure 3-46, Figure 3-47). Other nearby switchgear and transformers (Figure 3-48) appeared to be anchored to the slab.

Figure 3-45. DPF generator and its seismic restraint

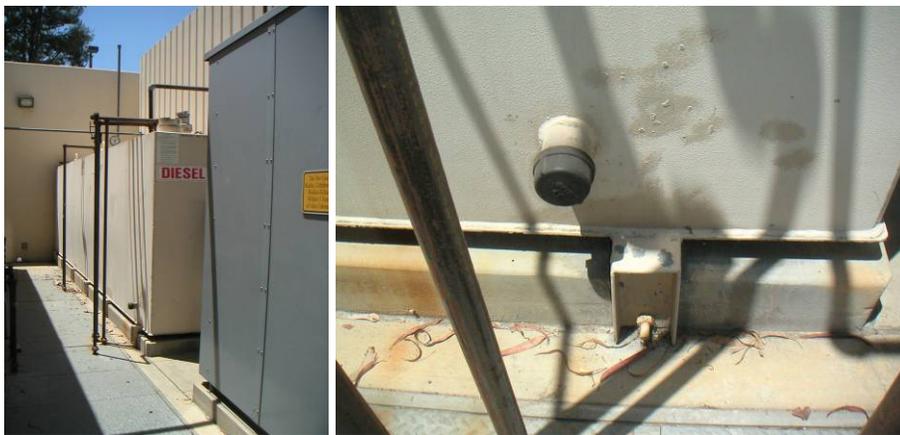
Figure 3-46. DPF generator's fuel tank and its seismic restraint

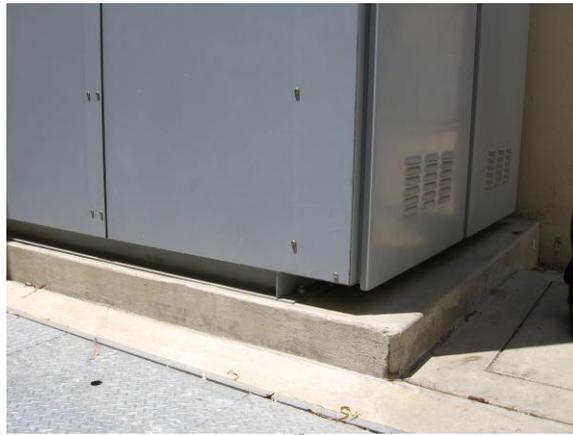
Figure 3-47. Seismic restraint of DPF generator's switchgear

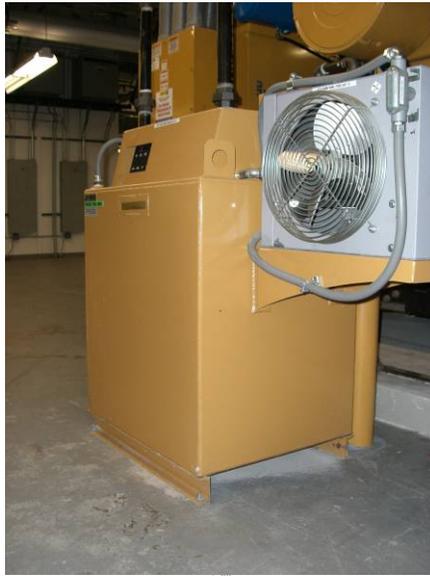
Figure 3-51. BDF generator day tank and electric fuel pump, apparently anchored to the slab

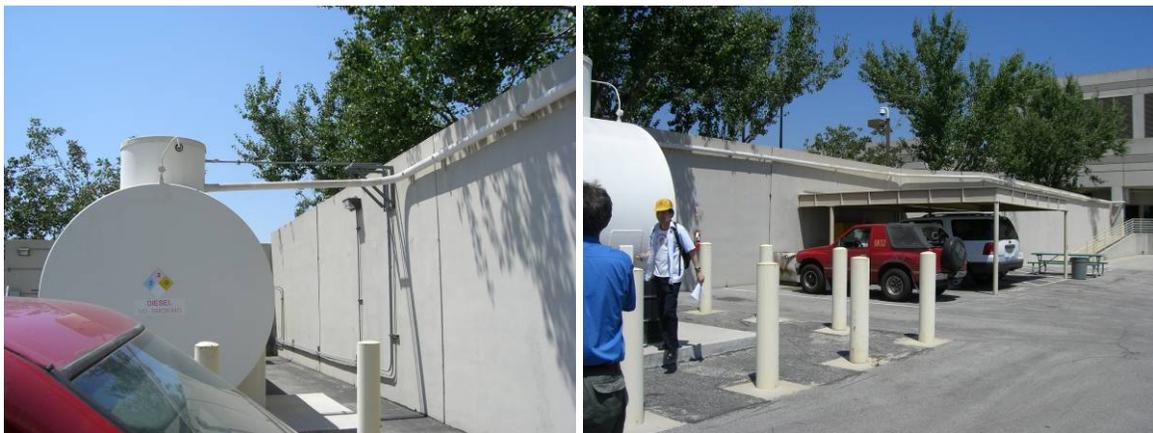
Each generator has a 50-gal day tank and we were told burns approximately 110 gal/hr. A 20,000 gal fuel tank outside the building and anchored to its plinth (Figure 3-53) therefore provides up to 180 hr (8 days) of fuel. The fuel pump is inside the tank. We observed that the supply pipe that runs between the tank and the generators is secured along about 125 ft to a heavy concrete fence comprising seven panels with no connection between them (Figure 3-54). Differential displacement of the tops of these panels could conceivably rupture the supply pipe, both disrupting on-site power generation and causing a hazardous material spill. In that event the generator could possibly be supplied by manually filling 55-gallon drums (one was observed next to the tank) and hauling them up to the generator day tanks. An alternative approach would be to provide a shutoff valve on the pipe run from the tank and an alternative point for injecting fuel into the supply pipe from a tanker parked at the loading

dock, where the pipe enters the building (Figure 3-55). Failure of the diesel supply pipe along this fence may represent an important weak link at this facility.

Figure 3-54. Fuel line secured to a long segment of concrete fence at BDF

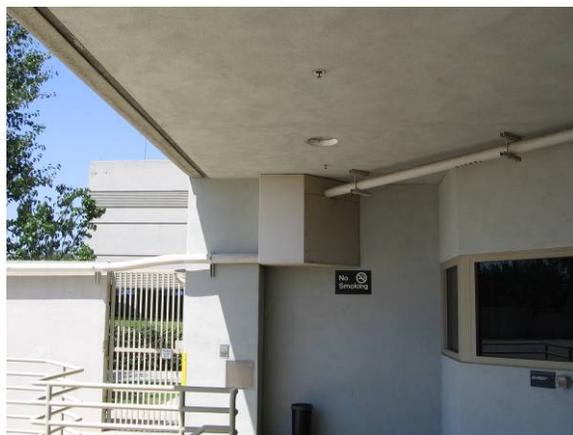
Figure 3-55. Possible access point on the loading dock for alternative method of fueling diesel generators in case the fuel pipe breaks on the concrete fence

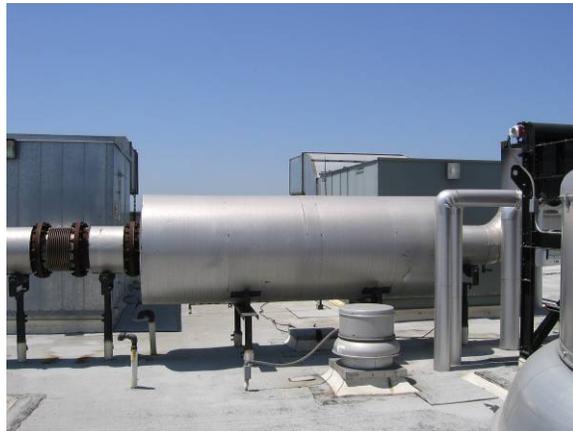
to lack positive seismic restraint (Figure 3-57) and an enclosure containing air intake fan with equipment to cool the outside air before it is fed into the generator (Figure 3-58). The intake fan motor had vibration isolators with questionable resistance to lateral displacement. The lack of seismic restraint for the mufflers is presumably not a critical issue, as long as local authorities would allow the generators to be run despite damage to the mufflers. Damage to the air intake fans could conceivably prevent the generators from operating, so the light vibration isolators might be more of a reliability issue.

Figure 3-57. Muffler for BDF emergency generator

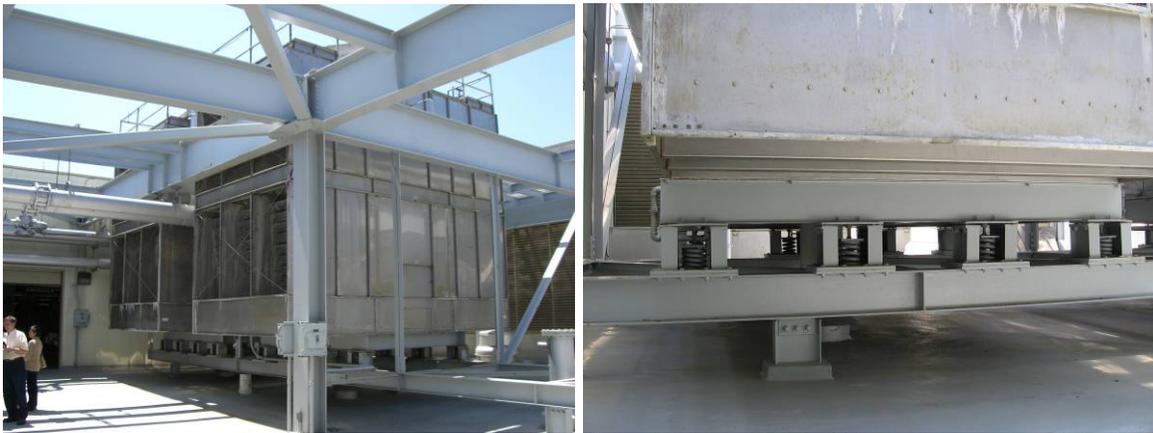
Cooling towers. There are two 1000-ton cooling towers at the facility with isolators that provide resistance to uplift and lateral displacement (Figure 3-59). There are two 30,000-gal water storage basins, each with three redundant pumps anchored to the floor (Figure 3-60). The cooling towers lose up to 500 gal/hr to evaporation, so if off-site water supply were lost, the basins could supply at least 60 hr of water for cooling. The basins can be refilled from trucks outside the facility.

Figure 3-59. BDF cooling towers and their anchorage

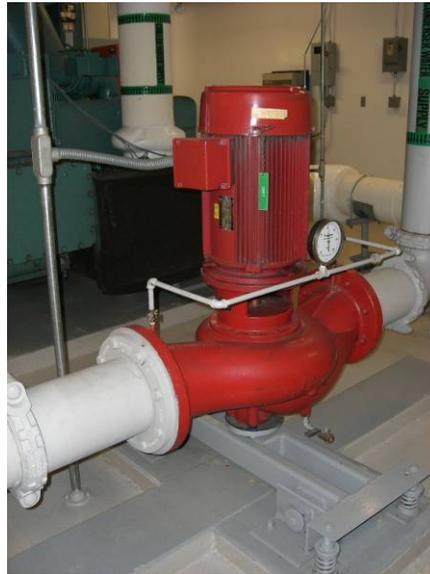
Figure 3-62. Compressors in BDF appeared to be seismically restrained

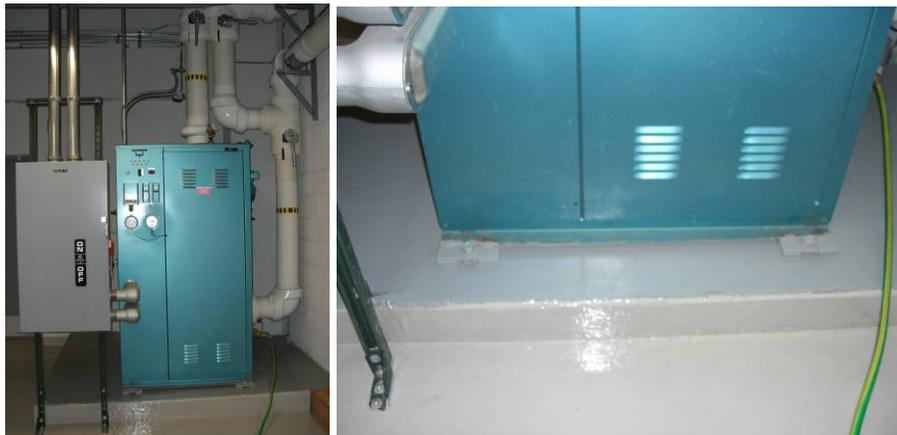
Figure 3-63. BDF electric boilers, apparently seismically anchored

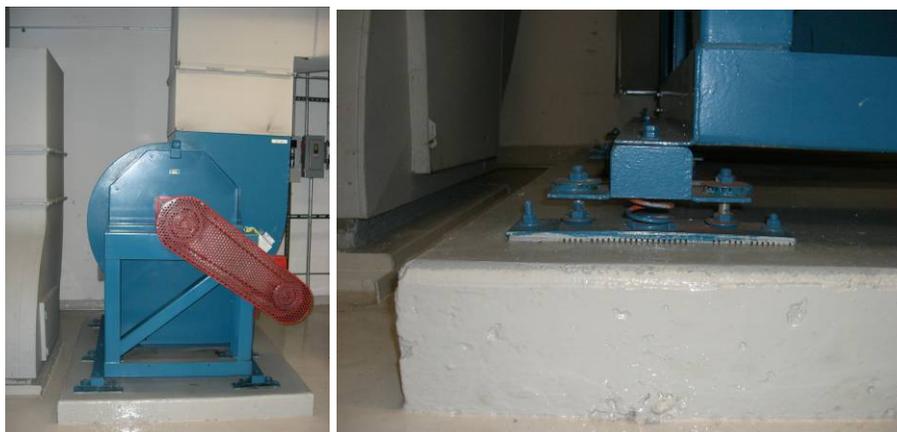
Figure 3-64. Fans in BDF for warm air, without apparent seismic restraint

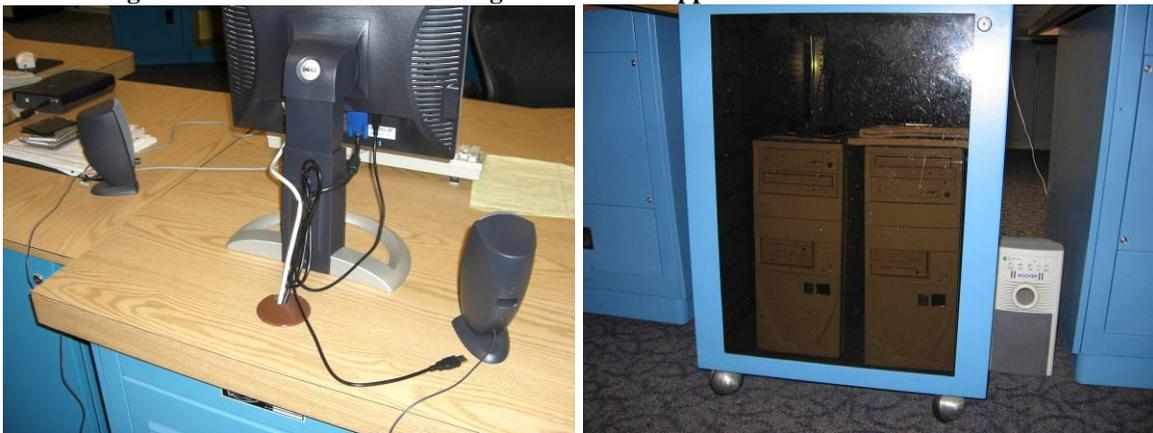
monitors are not secured and at least some system units were in unrestrained cabinets (Figure 3-66). Suspended ceilings in this room appeared to have compression struts and diagonal splay wires, but not in the same places as would be required for modern construction (Figure 3-67). The ceiling is captured all the way around by walls, which tend to be more remediate this problem. However, ductwork and automatic sprinkler lines appeared largely to lack lateral restraint that would help to mitigate the potential for seismic damage (Figure 3-68). An equipment closet in this room contains approximately 20 non-redundant DDC panels fastened to the wall (Figure 3-69). Of some concern is the fact that this closet has automatic sprinklers rather than Halon. If the sprinkler pipe were damaged or water were otherwise discharged, it could conceivably damage all these panels. Although building engineers informed us that all the building service equipment can be run manually, the ceiling system in the control center, the sprinklers in this equipment closet, and the lack of seismic restraint for the computers in this room may represent important weak links at this facility.

Figure 3-66. Some computer equipment in BDF building control room lack seismic restraint

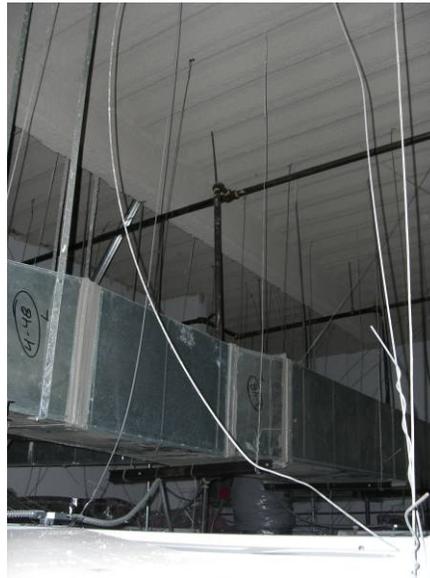
Figure 3-68. Ductwork and automatic sprinkler lines in BDF building control room appeared largely to lack lateral restraint.

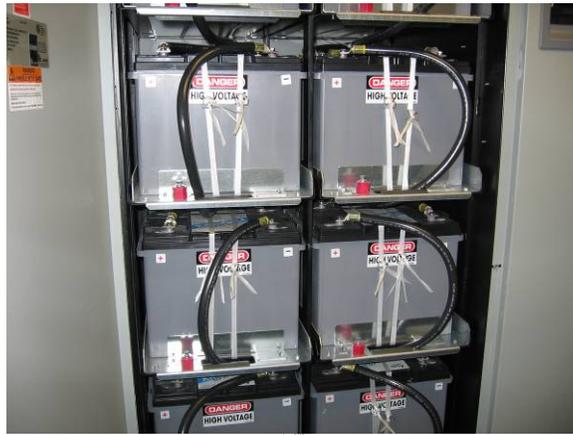
UPS equipment. We observed four battery modules, with three cabinets per module, all apparently anchored to the slab (Figure 3-71). Batteries for the most part appeared to be secured to their racks (Figure 3-72). We did not observe whether the batteries have spacers, but as the image shows, conductors between batteries appeared to be flexible cable and thus less subject to fracture in case the batteries pound into each other inside the cabinet. We observed a (non-critical) battery charging rack without apparent anchorage (Figure 3-73). Two redundant systems of two uninterruptible power modules per system (rectifier, inverter, etc.) appeared to be anchored to the slab (Figure 3-74). Air conditioning equipment near the UPS systems appeared to be anchored to the slab (Figure 3-75).

Figure 3-72. UPS batteries at BDF

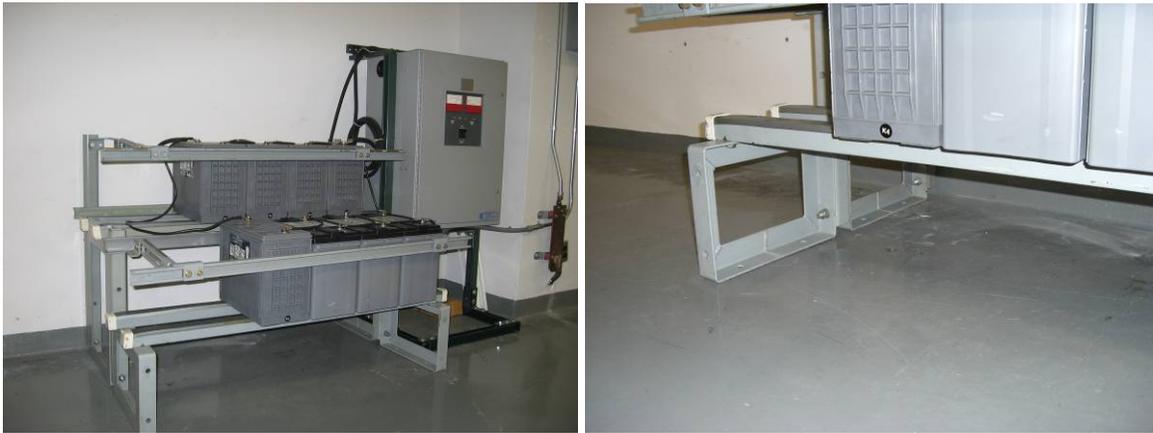
Figure 3-73. Non-critical battery charging rack at BDF without apparent anchorage to the floor

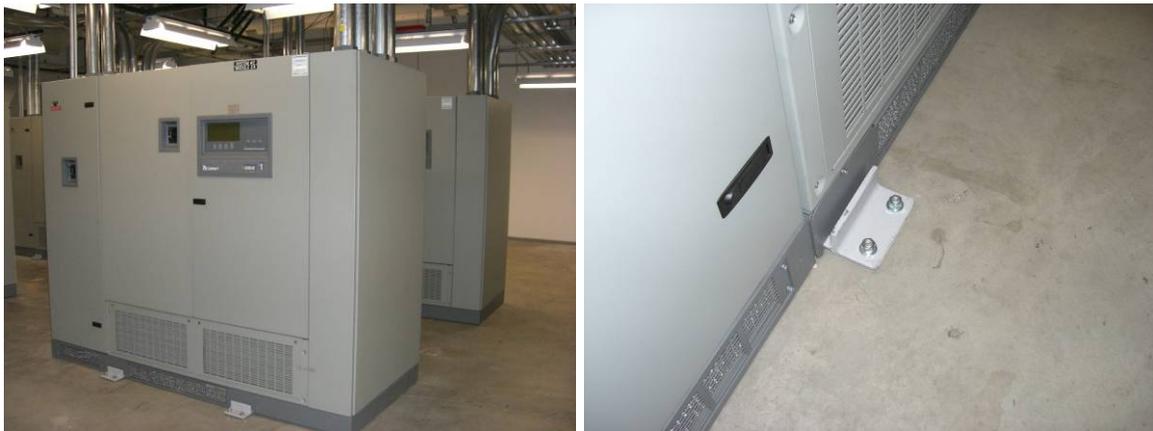
Figure 3-74. UPS equipment at BDF apparently anchored to the floor slab

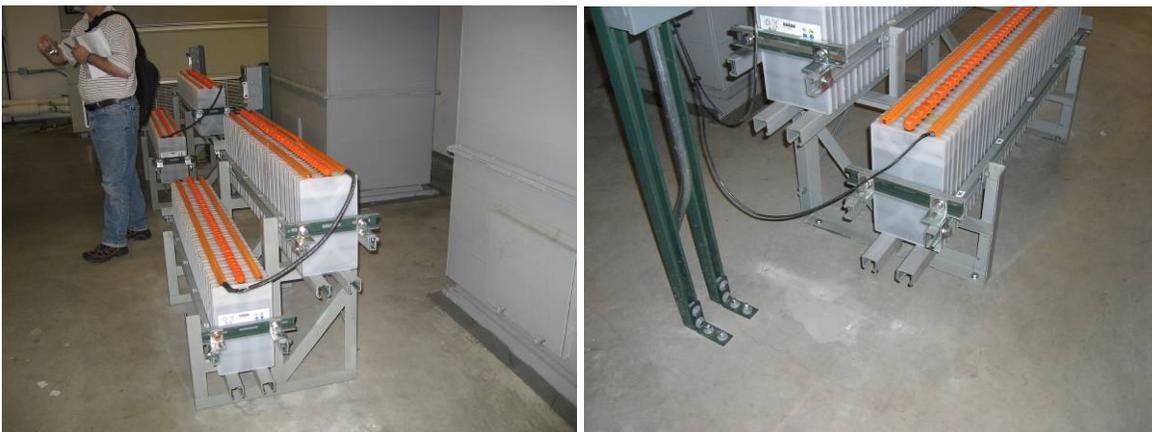
Switchgear room. We observed two long panels of switchgear, all apparently anchored to the concrete plinth (Figure 3-78), and two racks of batteries to power these, also anchored to the slab and having longitudinal bracing and no need for battery spacers (Figure 3-79).

Figure 3-79. Battery racks, apparently well anchored, with restrained batteries and longitudinal braces

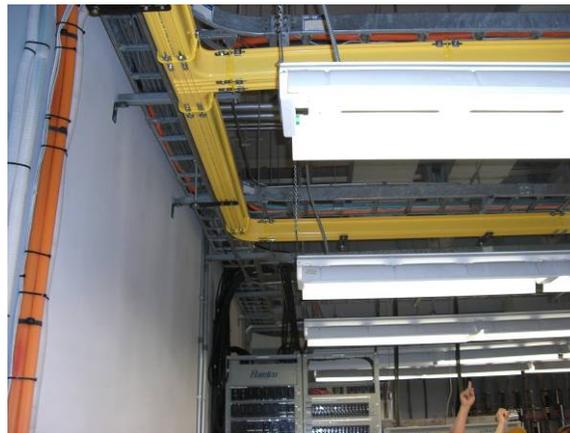
Figure 3-81. Overhead cable trays in BDF telecommunications room appeared to be braced to the wall

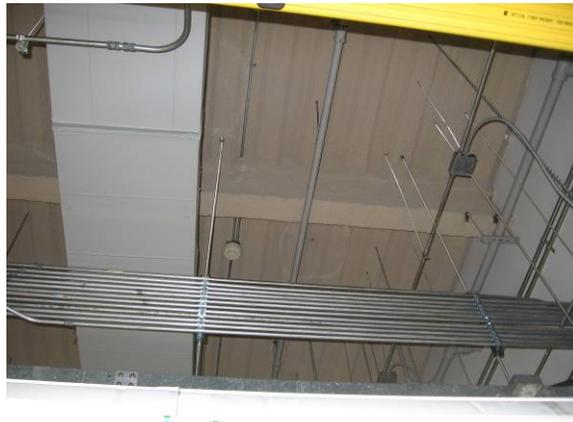
Figure 3-82. Long unbraced runs of sprinkler pipe in BDF telecommunications room

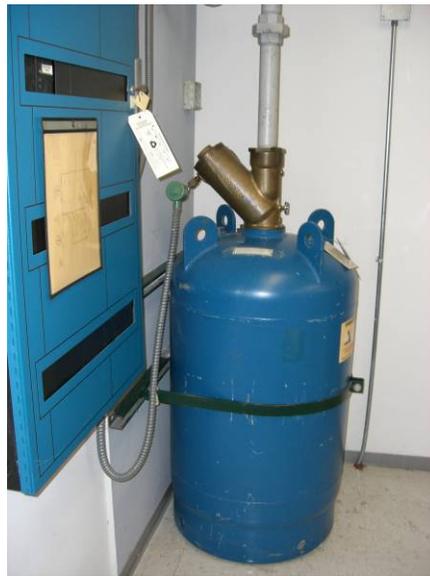
Figure 3-83. Halon tank in BDF telecommunications room, apparently strapped to the wall

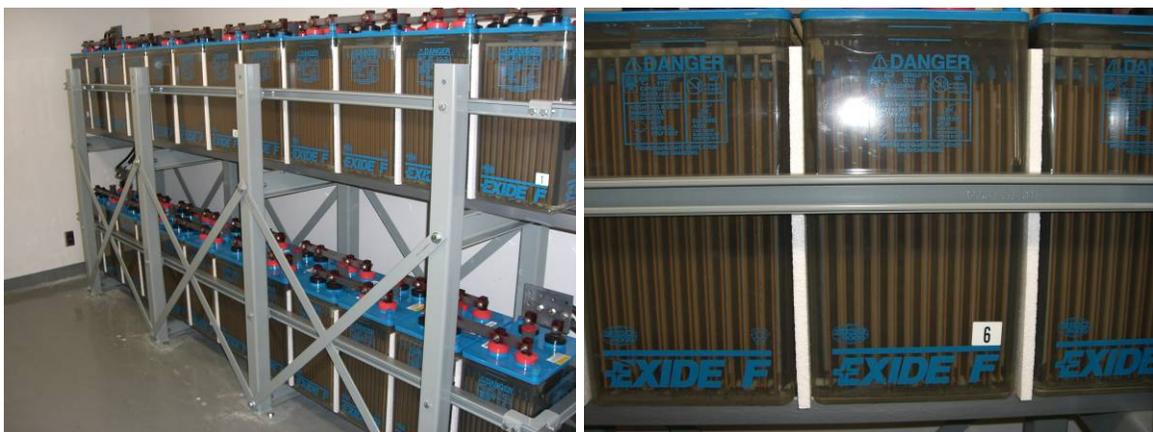
telecommunication equipment appeared to be secured to the floor slab (Figure 3-80). Overhead cable trays appeared to be braced to the wall (Figure 3-81). The room is protected by automatic sprinklers as well as a Halon system, although building engineers informed us that the Halon system should suppress any fire and prevent the fusible links on the automatic sprinklers from melting and causing water to discharge, although as elsewhere long unbraced runs of pipe (Figure 3-82) raise increase the probability of earthquake sprinkler leakage. The Halon tank appeared to be secured to the wall (Figure 3-83). The telecommunications switching equipment has its own battery rack, anchored to the slab, with longitudinal braces and battery restraints and spacers, all desirable features for seismic resistance (Figure 3-84).

Figure 3-84. Battery rack for telecommunications equipment

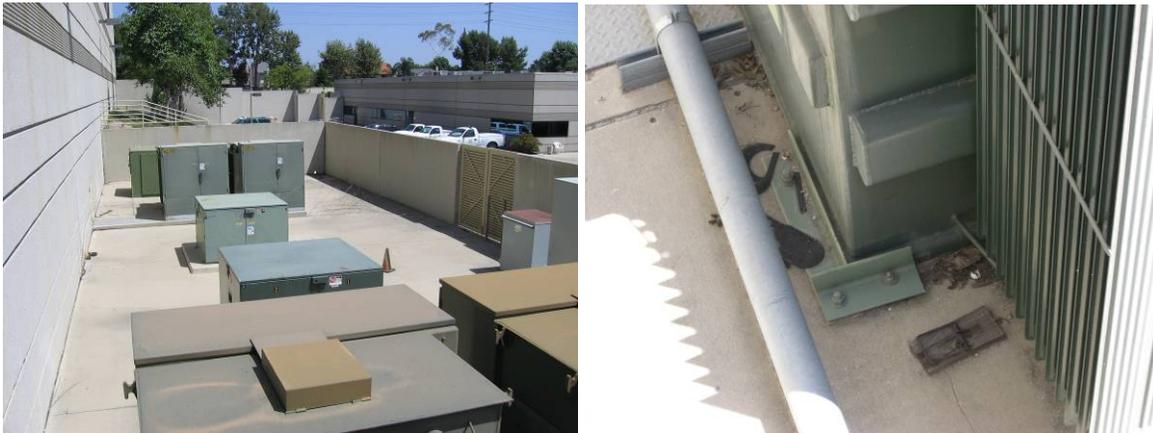
visit, but equipment near a vantage point appeared to be restrained from sliding (Figure 3-85).

Figure 3-85. Transformer vault at BDF, and apparent seismic restraint of its equipment

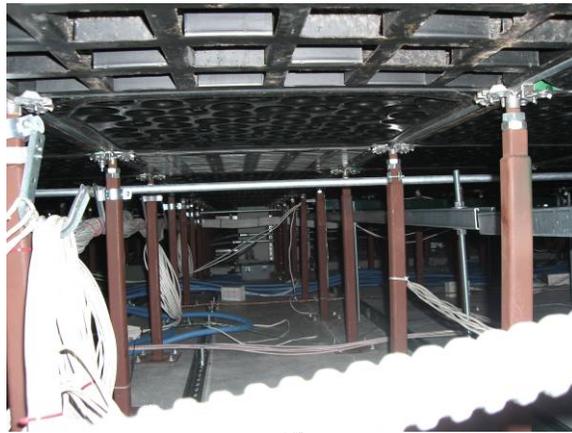
CPU room. This large room stands on 2-ft raised access flooring. The pedestals within sight of our vantage point lack diagonal bracing, and were anchored at four corners with epoxy anchors (Figure 3-86). Equipment in this room is restrained by various systems, for example, bolted to IBM anti-tip plates in front and an innovative angle bracket to a rear wheel axle. These are then secured to a steel cable tether, with turnbuckle to adjust for tautness, itself secured to a Unistrut member secured to the slab below (Figure 3-87). We were told that all equipment in this room weighing in excess of 400 lb is tethered in this fashion. Lighter equipment is secured against overturning by threaded rods secured to the levelers and anchored to the slab below, as at DPF. It is conceivable that the tethers on the larger equipment could act to restrain the raised access floor in the absence of diagonal braces, but because the tethers are not taut, and are not designed to restrain the floor, the raised access flooring is more likely to collapse than if diagonal braces were present. Unbraced raised access flooring could be an important weak link at this facility.

Figure 3-86. Raised access floors at BDF CPU room, apparently lacking braces

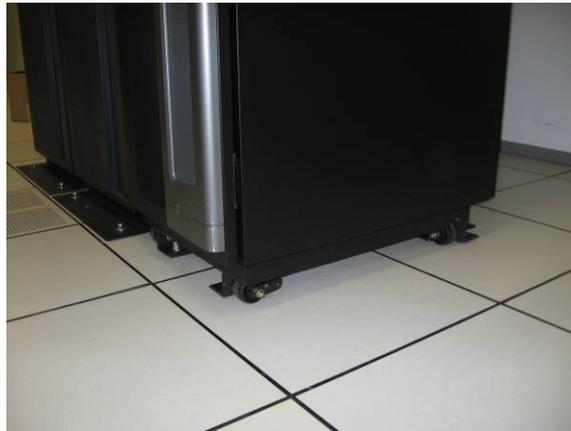
Tape silo room. Similar to the data processing facility, four cylindrical tape silos in the backup data facility rest on 12-in raised access floor. While some controllers appeared to be seismically restrained (Figure 3-91), the cylindrical silos themselves are not, and are therefore more likely to slide, pound against each other, and possibly become inoperative in an earthquake (Figure 3-92). This may be an important weak link at this facility.

Figure 3-91. Seismic restraint of controllers in BDF tape silo room

most effective mitigation measure for this facility would be to mitigate the tape silos, either by seismic restraint (if that is possible for these pieces of equipment) or by relocating them at a seismically stable location. If the tape silos could be made seismically rugged, doing so would increase to 0.33g the *PGA* at which failure is more likely than not. By strengthening all components identified here as possible weak links, the *PGA* associated with 50% failure probability is increased to 0.85g. Note that we have assumed that damage to the tape silos is perfectly correlated—if one fails, all fail, which we deem reasonable given their proximity. See Figure 4-1b.
