Analysis of Simultaneous Operational Failure of Critical Facilities due to Earthquake, for a California Utility

Prepared by
CALIFORNIA INSTITUTE OF TECHNOLOGY

**Aug 7, 2006
Rev 1**

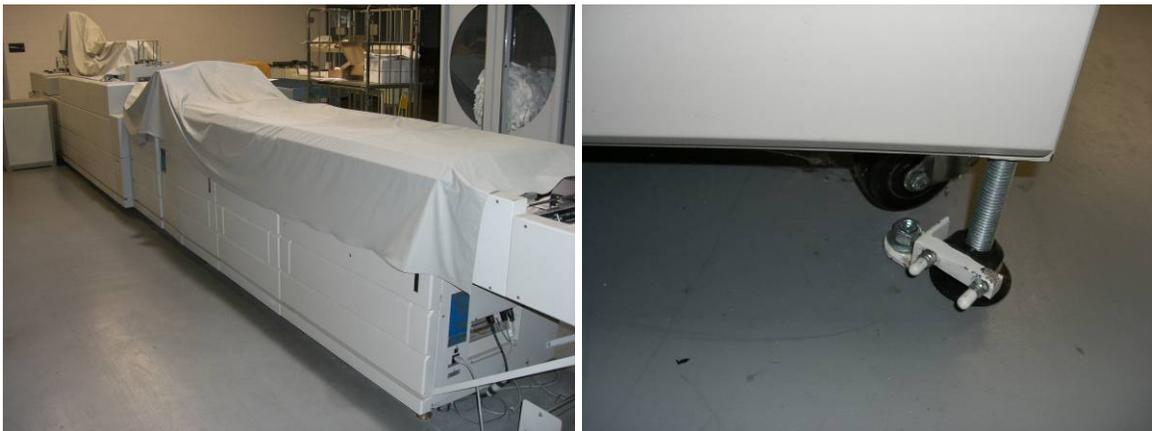
Figure 3-94. Restraint of document handling equipment in BDF

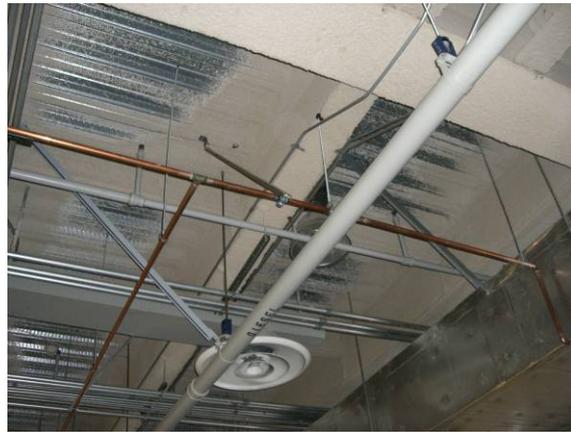
Figure 3-95. Long unbraced lengths of sprinkler pipe and minimally braced copper air pipe in BDF

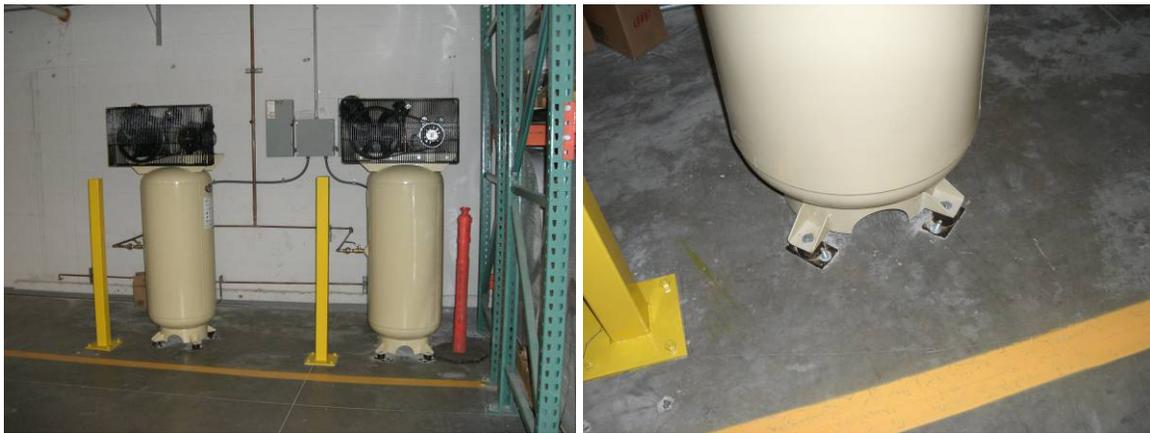
Print room and document handling equipment. The print and distribution area stands on 1-ft raised access flooring. Equipment in this room is tethered to the floor panels (Figure 3-93); we do not know whether the bolts connected to the floor panel are themselves restrained to the slab below using a tethering system such as described above. Document insertion equipment in the warehouse (the alternate mailing operation center; no raised access floor) appears to be secured to the slab (Figure 3-94). Long unbraced lengths of sprinkler pipes and or minimally braced copper air lines were observed suspended from the deck above (Figure 3-95). Compressed air tanks and compressors (compressed air being needed by the document handling equipment) appeared to be anchored to the floor slab (Figure 3-96).

Figure 3-96. Anchorage of air tanks and compressor assemblies in BDF
