THE LOMA PRIETA, CALIFORNIA, EARTHQUAKE OF OCTOBER 17, 1989:
STRONG GROUND MOTION AND GROUND FAILURE

MARINA DISTRICT

PERFORMANCE OF EMERGENCY-RESPONSE SERVICES
AFTER THE EARTHQUAKE

By Charles R. Scawthorn and Keith A. Porter, EQE Engineering and Design; and
Frank T. Blackburn, PWSS Co., Ltd.

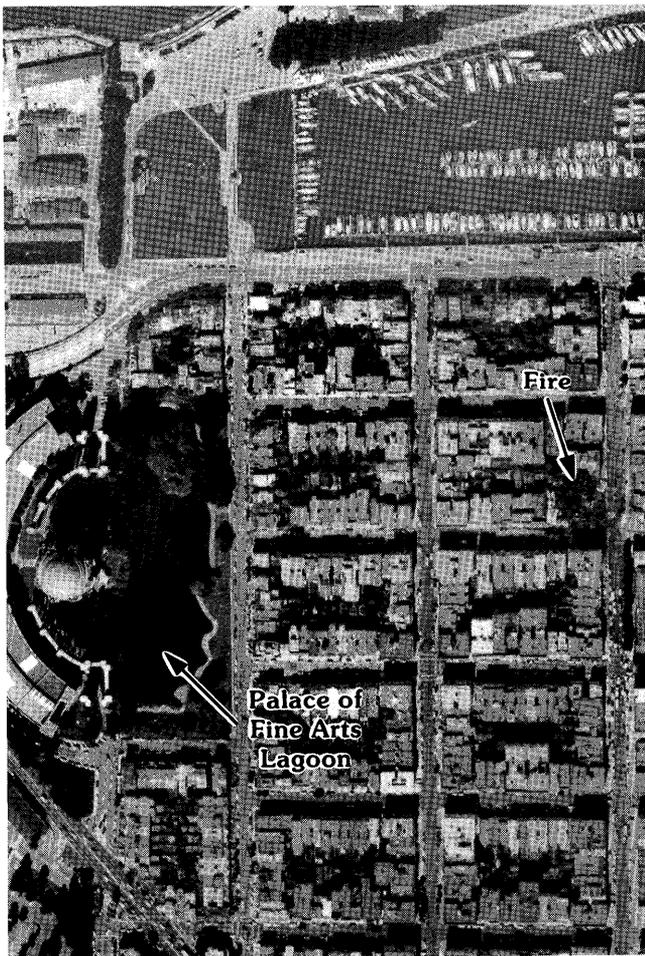
Engine 21 abandoned the AWSS hydrant and fixed on another source of water: the lagoon at the Palace of Fine Arts, just two blocks to the west (fig. 13). According to Capt. Costella's report:

Figure 13.—Western part of Marina District, showing location of fire relative to lagoon at the Palace of Fine Arts. Photograph taken October 18, 1989.

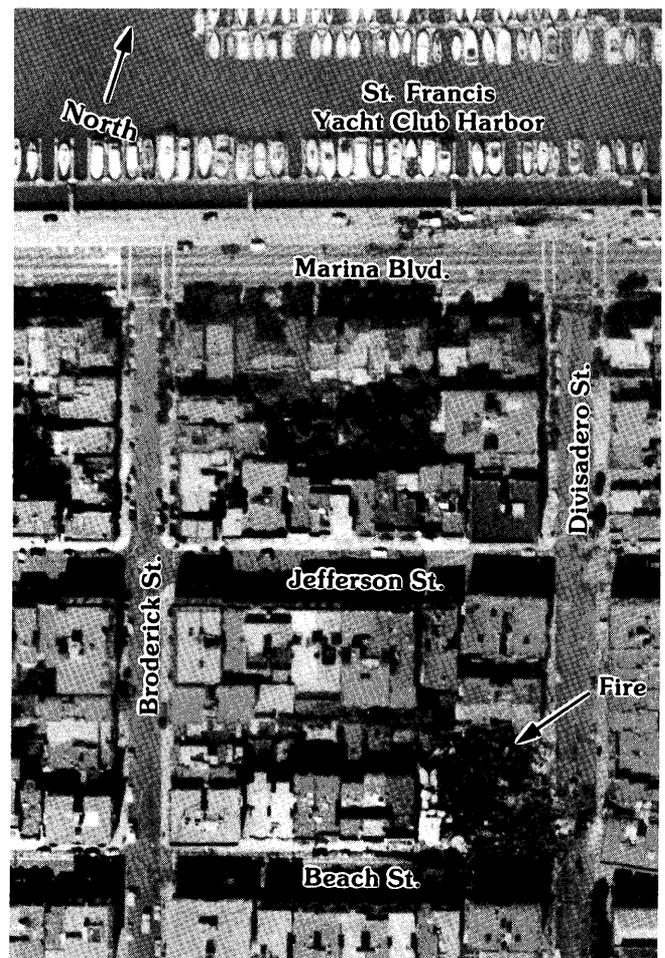
The now-complete crew of Hosetender 25 began immediately to make the initial 5-in.-diameter hose lead. It ran from Marina Boulevard up Divisadero Street to Beach Street and included two portable hydrants, with 900 ft of 5-in.-diameter hose. Hosetender 25 was then positioned on the east flank of the fire (fig. 14); from this position, they would be able to protect the buildings across, and farther north on, Divisadero Street.

Figure 14.—Northwestern part of Marina District, showing location of the St. Francis Yacht Club Harbor. Hosetender 25 was located immediately to right of fire. PWSS hose leads from yacht harbor are visible on Divisadero and Broderick Streets. Photograph taken October 18, 1989.

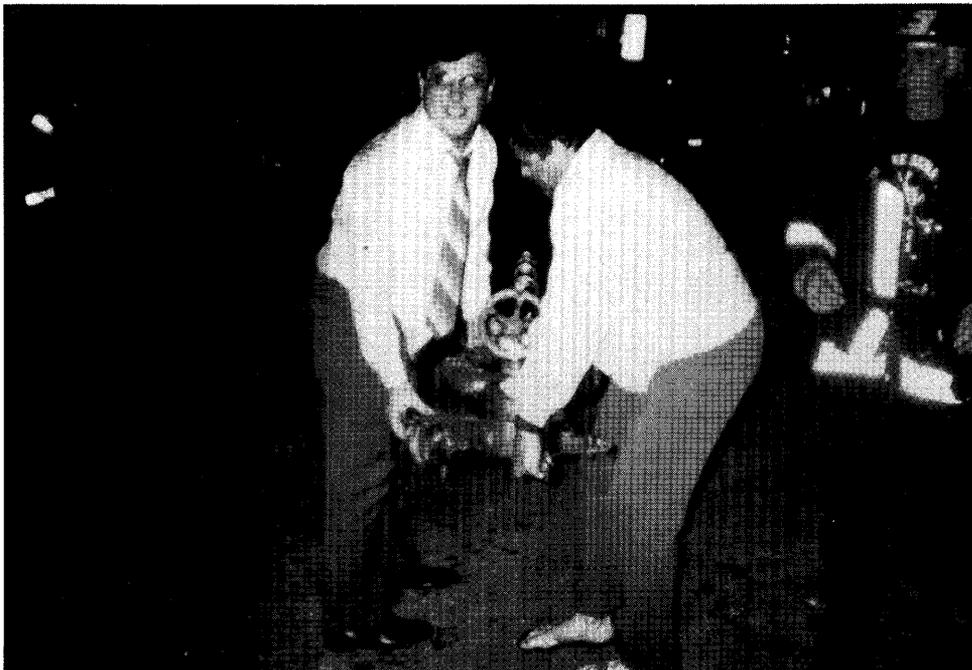
Indeed, there were plenty of volunteers (fig. 18). An offduty police officer at home in his apartment on Divisadero Street near Beach Street felt the earthquake, took his daughter out of the building, went back inside to get his shield, and emerged again to take control of the area. Civil-

Figure 18.—Volunteers assisted SFFD at fire. Note firefighter at right. Photograph by C.R. Scawthorn.
