Utility Performance Aspects, Liquefaction Study, Marina and Sullivan Marsh Areas, San Francisco, California

Charles Scawthorn, Keith Porter and Mahmoud Khater
EQE International
San Francisco, CA 94104

ABSTRACT

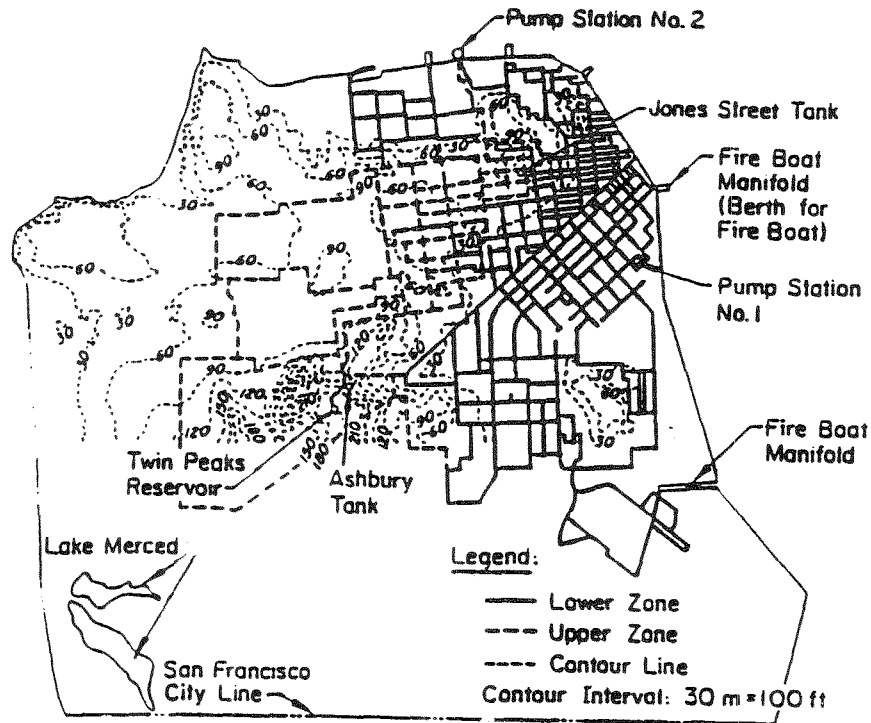
Figure 1
SAN FRANCISCO AWSS

AWSS The San Francisco AWSS is a water supply system intended solely for adequate water supply for firefighting. It is separate and redundant from the MWSS, and is owned and operated by the SFFD. It was built in the decade following the 1906 San Francisco earthquake and fire, primarily in the north-east quadrant of the city (Figure 1, the urbanized portion of San Francisco in 1906 and still the central business district), and has been
