PERFORMANCE OF WATER SUPPLY PIPELINES IN LIQUEFIED SOIL

K.A. Porter, C. Scawthorn, D.G. Honegger¹, T.D. O'Rourke², F. Blackburn³

ABSTRACT

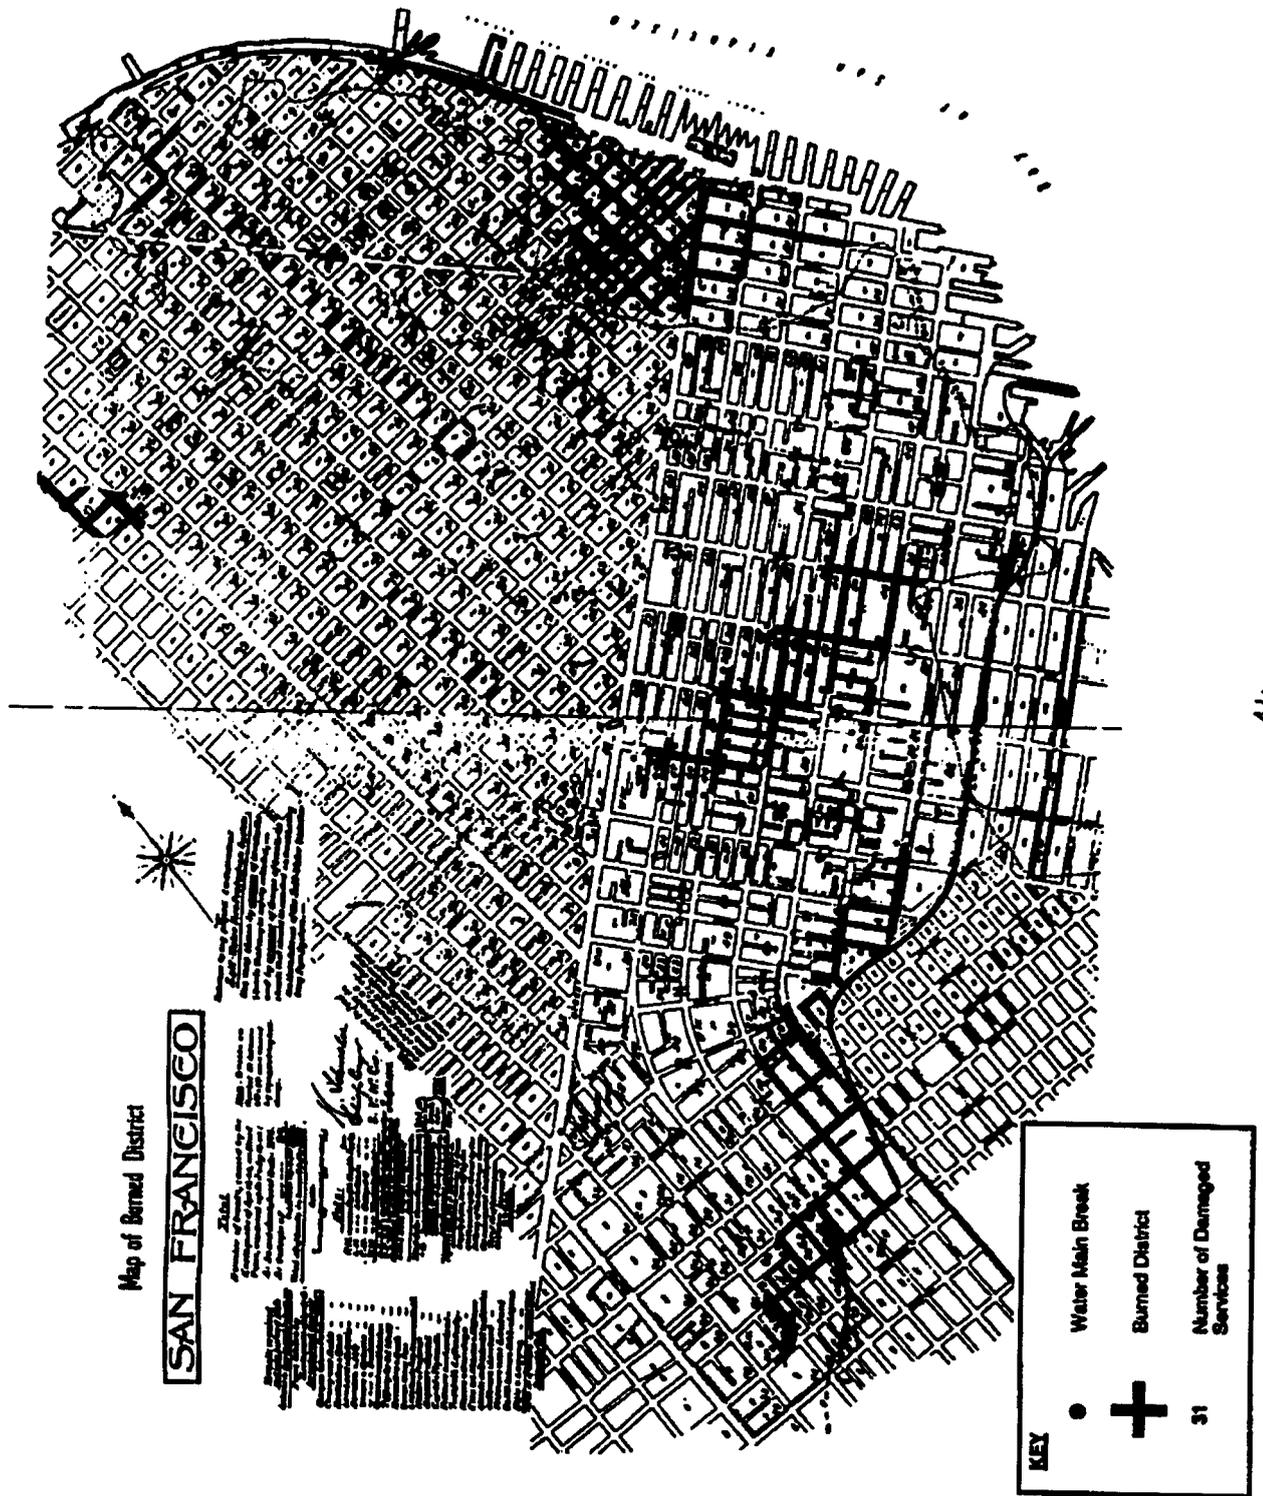
Figure 3: 1906 water main breaks (Schussler, 1906)

Several authors provide data or correlations between pipe breakage and degree of permanent ground deformation. O'Rourke et al (1989) describe ground movement as well as pipe breakage in San Francisco's Sullivan Marsh and Mission Creek in the 1906 San Francisco earthquake. Pipe breakage data is taken from Schussler (1906), who provided a map showing water main breaks identified in the three months following the earthquake (Figure 3). Using photographs and other records, O'Rourke mapped ground movements in the Embarcadero and South of Market (e.g., Figure 4).

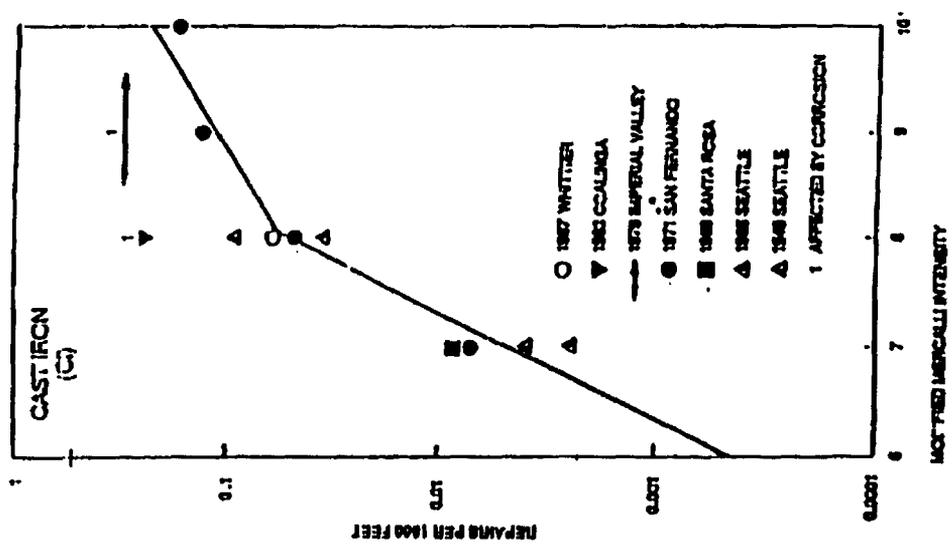
Figure 1-1. Earthquake Damage Data for Cast-Iron Pipe-Shaking Effects Only
Reference: After Eguchi (1983)

Figure 1: Damage data for shaking effects only (after Eguchi 1983, appended by Harding Lawson et al, 1991)

Eguchi (1983b) summarized pipe break rate versus MMI for several United States earthquakes, developing a bilinear semilogarithmic curve for cast iron pipe subject to ground shaking effects only (Figure 1). He found that damage rates increase rapidly with MMI, and then more slowly as MMI exceeds VIII.

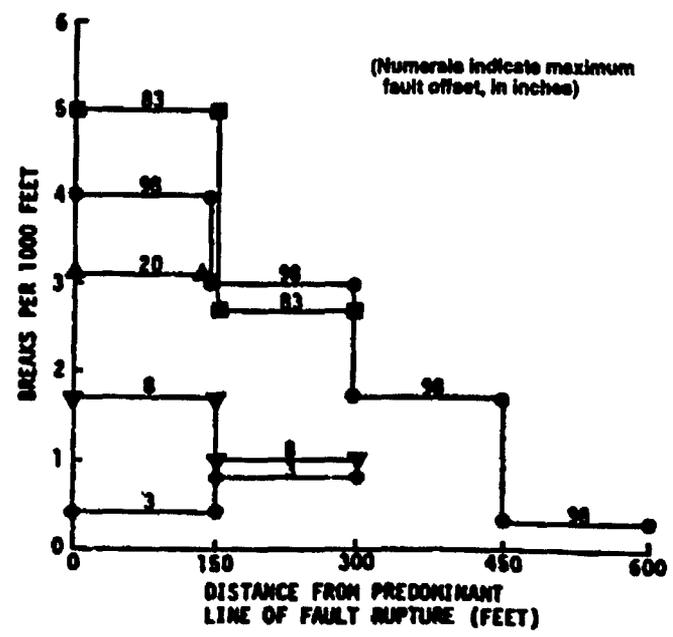
Figure 2: Effect of fault rupture (Eguchi, 1983)

Eguchi (1981) presents damage to buried cast iron water pipe near faulting during the 1971 San Fernando Earthquake. He correlated damage with fault displacement and distance from the predominant line of fault rupture (Figure 2). Ground shaking effects accounted for relatively little breakage.

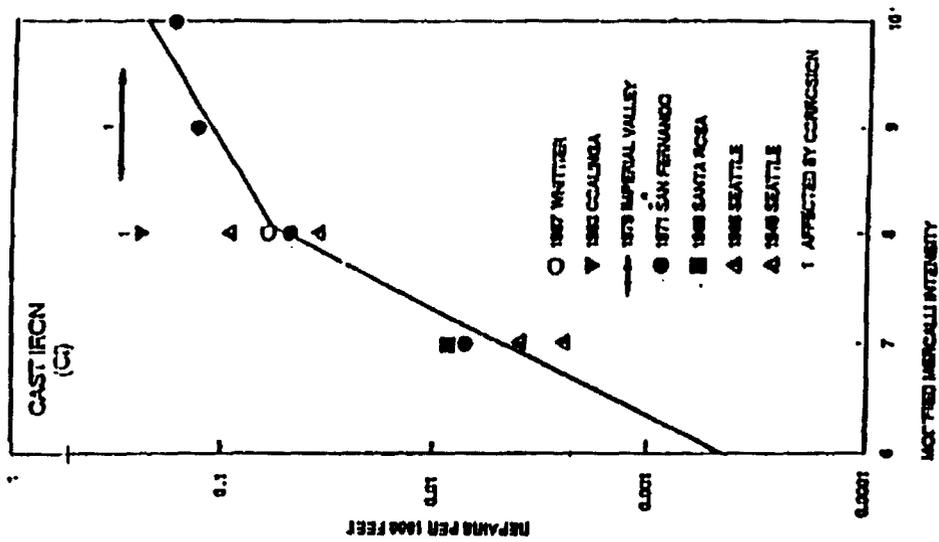
Figure 6-1. Earthquake Damage Data for Cast-Iron Pipe-Shaking Effects Only
Reference: After Eguchi (1983)

Figure 1: Damage data for shaking effects only (after Eguchi 1983, appended by Harding Lawson et al, 1991)

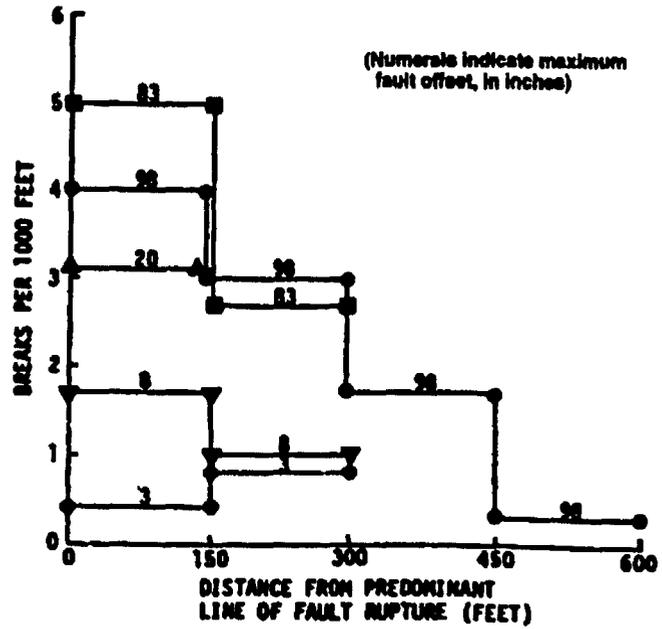
Figure 2: Effect of fault rupture (Eguchi, 1983)

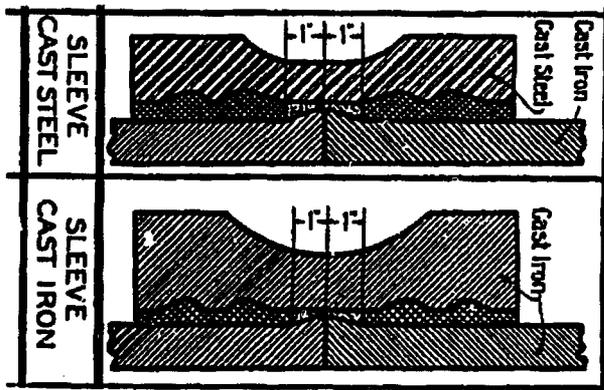
Figure 6: Double spigot joint

Double spigot joints use cast iron or cast steel sleeves, sealed with lead and oakum, as shown in Figure 6. This type of construction allows twice as much joint rotation as does bell and spigot construction with a similar lead/oakum seal. The Schedule H pipe used in the AWSS has walls typically 60% thicker than those of the MWSS cast iron pipe. Since the AWSS operates at higher pressure than MWSS, extra restraint is employed. Rods connect as many as 10 pipe segments at turns, tee joints, hills and other points of likely stress, as opposed to the restraint of one joint in MWSS tees. Finally, since AWSS contains no service connections (it is a dedicated firefighting only system), laterals occur only at hydrants and branches. Laterals provide restraint and may act as concentrated load points on a water main, potentially resulting in additional pipe damage.

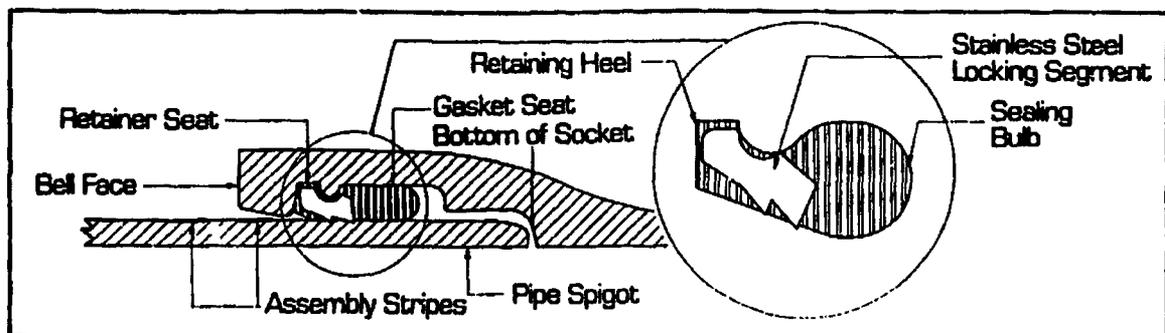
Figure 7: Field Lok Gasket (U.S. Pipe)

Since 1989, SFWD pipe joints have employed U.S. Pipe's Field Lok Gasket, an elastomeric gasket fitted with mechanical teeth that provide longitudinal restraint (Figure 7). The gasket requires no packing, thereby allowing significant rotational flexibility.

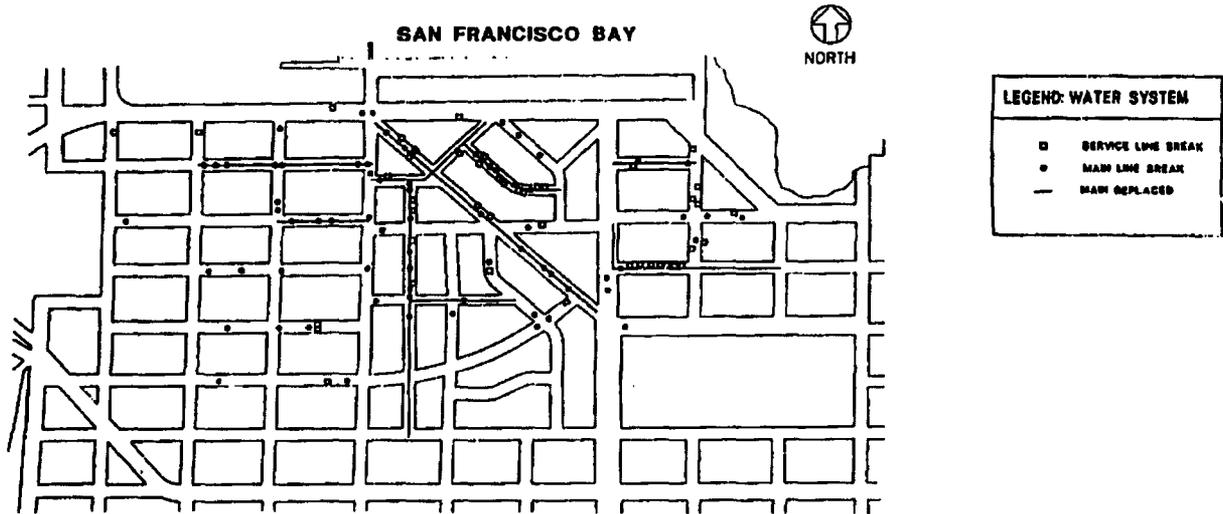
Figure 8: 1989 Marina water system breaks

The 1989 Loma Prieta earthquake resulted in over 160 MWSS pipe breaks, approximately 3/4 of which were located in the Marina District. Breaks within the Marina were concentrated in the regions of hydraulic fill created circa 1906-1917. Locations of water main and service breaks are shown in Figure 8, which is based on SFWD records. In the next section, these will be correlated with liquefaction-induced ground settlements. Lateral spreading as large as 7 inches over 100 feet is known to have occurred in the Marina in 1989 (Harding Lawson Associates et al, 1991), but lateral movements have not been mapped.

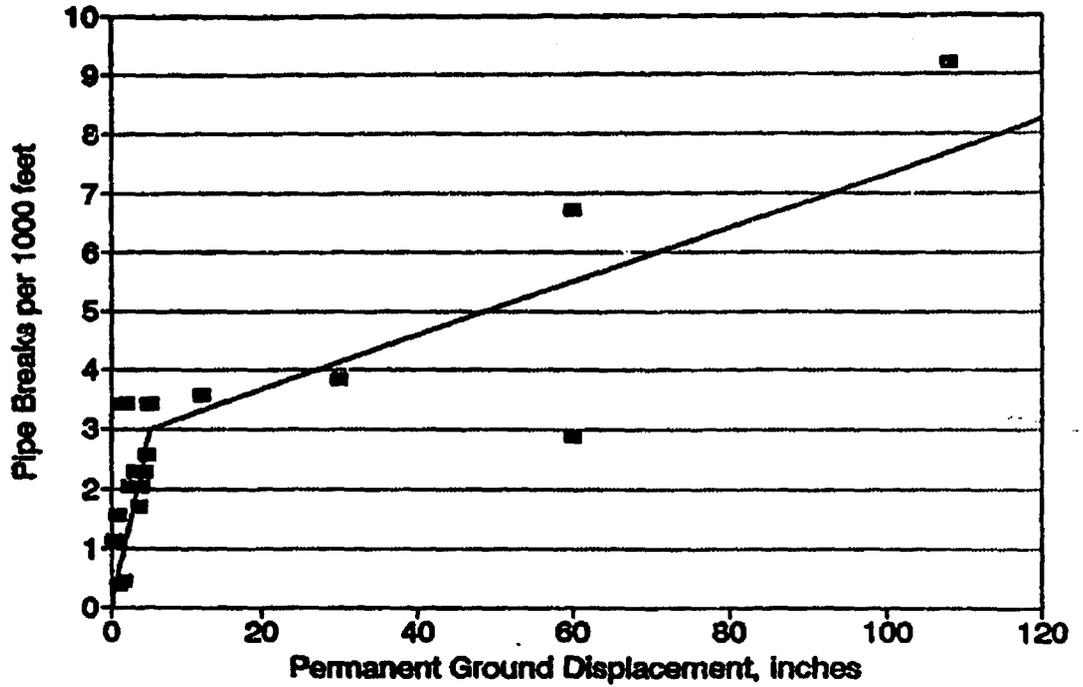
Figure 9: 1906 and 1989 cast iron water pipe damage

Regressions of the data were performed on both sets of data, and a combined set. The best fit was found as follows: (a) the 1989 data was treated as one set, and a regression was performed to fit a line with zero intercept over the domain 0 to 5 inches of displacement; (b) the 1906 data were treated as a separate set, and a regression was performed to produce a best fit line over the domain 5 inches to 9 feet; (c) a bilinear break rate curve resulted, as shown in Figure 9. A null hypothesis test indicates that a correlations exists with at least 95% confidence (Crow et al, 1960). These correlations and resulting curve apply only to bell and spigot cast iron pipe with lead and oakum joints.

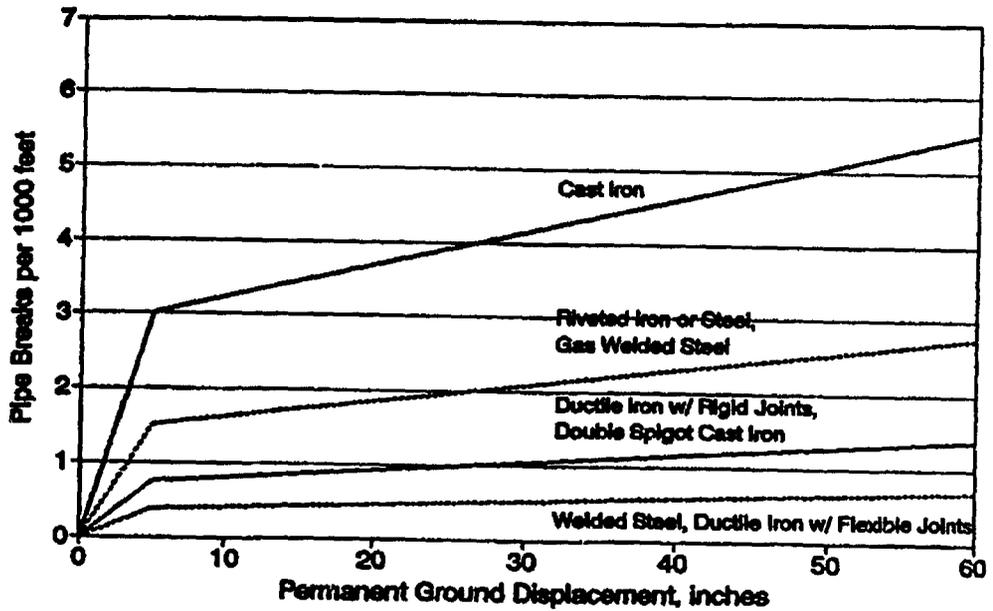
Figure 10: Estimated water supply pipe damage

Break rate functions developed using the methods discussed here are presented in Figure 10. These relationships indicate a trend of break rate increasing from 0 to 6 breaks per 1000 feet of pipe as permanent ground displacement increases from 0 to 6 feet. The trend and order of magnitude of damage tend to agree with Eguchi's data on pipe damage near fault rupture in 1971 San Fernando. In that earthquake, damage ranged from 0.4 to 5 breaks per 1000 feet near fault offsets as fault displacement increased from 3 to 98 inches. The figures developed for the present study are somewhat larger than Eguchi's figures for pipe damage in regions of liquefaction and landslide.
