CAPSS Soft-Story Loss Study

Scenario Losses to Large Soft-story Woodframe Buildings in San Francisco for ATC 52-2, Community Action Plan for Seismic Safety (CAPSS)

By
Keith Porter
SPA Risk LLC
Denver CO, USA

10 April 2009

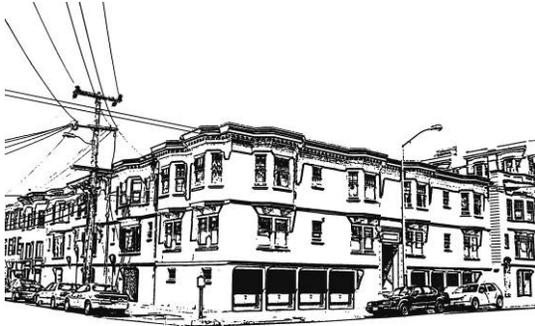
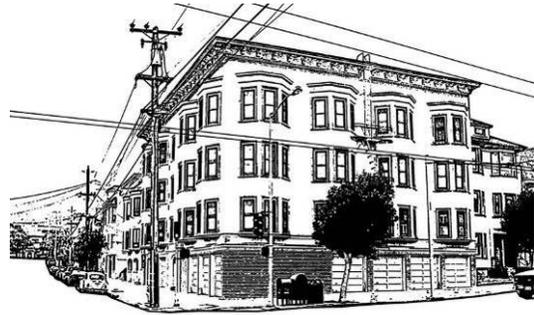
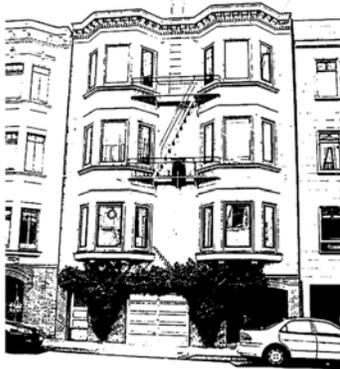
Figure 1. CAPSS index buildings. Four older, soft-story, woodframe, multifamily dwellings representing a realistic range of performance of buildings of this class in San Francisco: (1) corner, 3 story, no interior walls at garage level, one street facade $\geq 80\%$ open at ground floor; (2) corner, 4 story, both street facades $\geq 50\%$ open at ground floor; (3) mid-block, 4 story, pre-WWII, neighbors on both sides; (4) mid-block, 3 story, post-1950, neighbors on both sides. Square footage is 3,600, 5,800, 2,300, and 1,800 sf, respectively.

Cobeen (2008) designed 4 prototypical index buildings to represent the range of housing addressed here (Figure 1). The designs and 3 retrofits each were selected in consultation with DBI and consulting structural engineers. Each building in the exposed building stock was associated with the damageability information described in a companion document, Porter (2008a), as follows.

- Index building 1 (IB1): This is a 3+ story corner building with garage openings on one side of the building only. Therefore, corner woodframe buildings in the DBI database were associated with IB1 when they met the CAPSS “Significant Ground Floor Openings” criterion 1 (80% or more open on any one side), but did not meet criterion 2 (50% or more open on any two sides).

- Index building 2 (IB2): This is a 3+ story corner building with ground-story openings for garages on two sides of the building. Corner woodframe buildings in the DBI database were associated with IB2 when they met criterion 2 (at least 50% open on any two sides).

- Index building 3 (IB3) is a midblock structure built before 1950, which most likely has straight sheathing on the exterior wall and wood lath and plaster interior wall finish. Accordingly, midblock soft-story buildings with 3+ stories and 5+ housing units, built before 1950 were associated with IB3.

- Index building 4 (IB4) is a midblock post-1950 building. The most important feature of IB4 is plywood sheathing on exterior walls and gypsum-board interior

wall finish. IB4 is therefore likely to be stiffer, stronger, and more damage resistant than IB3. Therefore, midblock soft-story buildings with 3+ stories and 5+ housing units built after 1950 were associated with IB4.
